NIST NCSTAR 2: Vol. I

Report of the Technical Investigation of The Station Nightclub Fire

June 2005

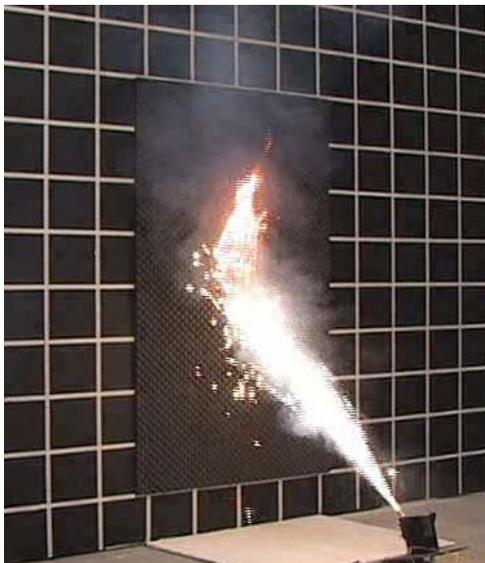
The hazard associated with the building contents was created by the close proximity of a high temperature source (a pyrotechnic device) and a substantial amount of material with a relatively low ignition energy and high flame spread rate (polyurethane foam). As could be seen in the WPRI video, flames spread rapidly over the foam, generating smoke and enough heat to ignite the wood paneling underneath and adjacent to the foam. The wood structure and paneling in the nightclub was estimated to contain over 95 percent of the fuel load, so that once most of the foam was consumed, the fire transitioned to a wood frame building fire.

Pyrotechnic device impinging on non-fire retarded polyurethane foam panel

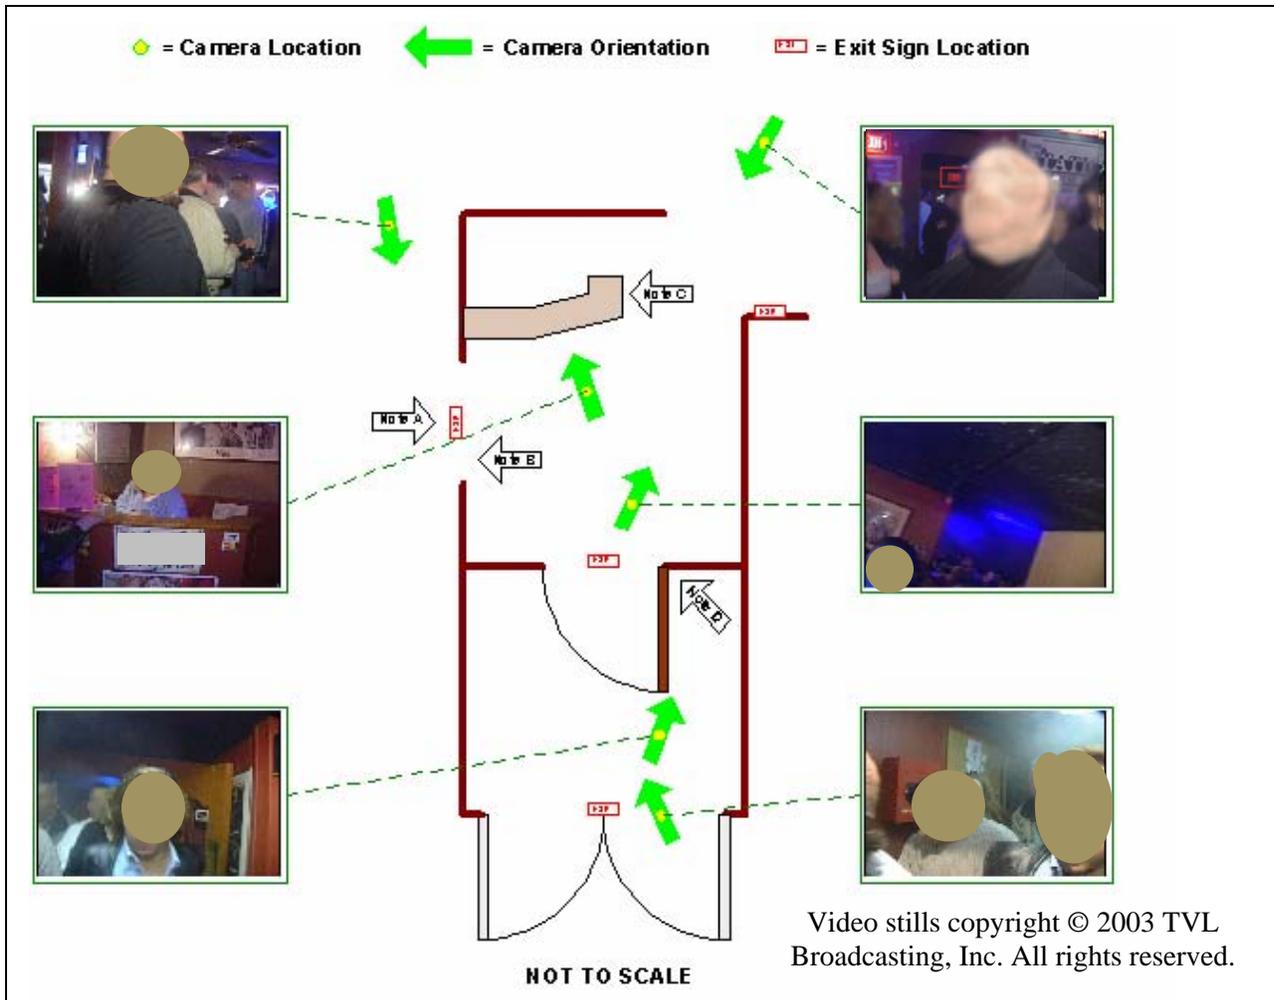
Figure 6-12. Detail of Main Exit Vestibule Area (Video frames copyright © 2003 TVL Broadcasting, Inc. All rights reserved)

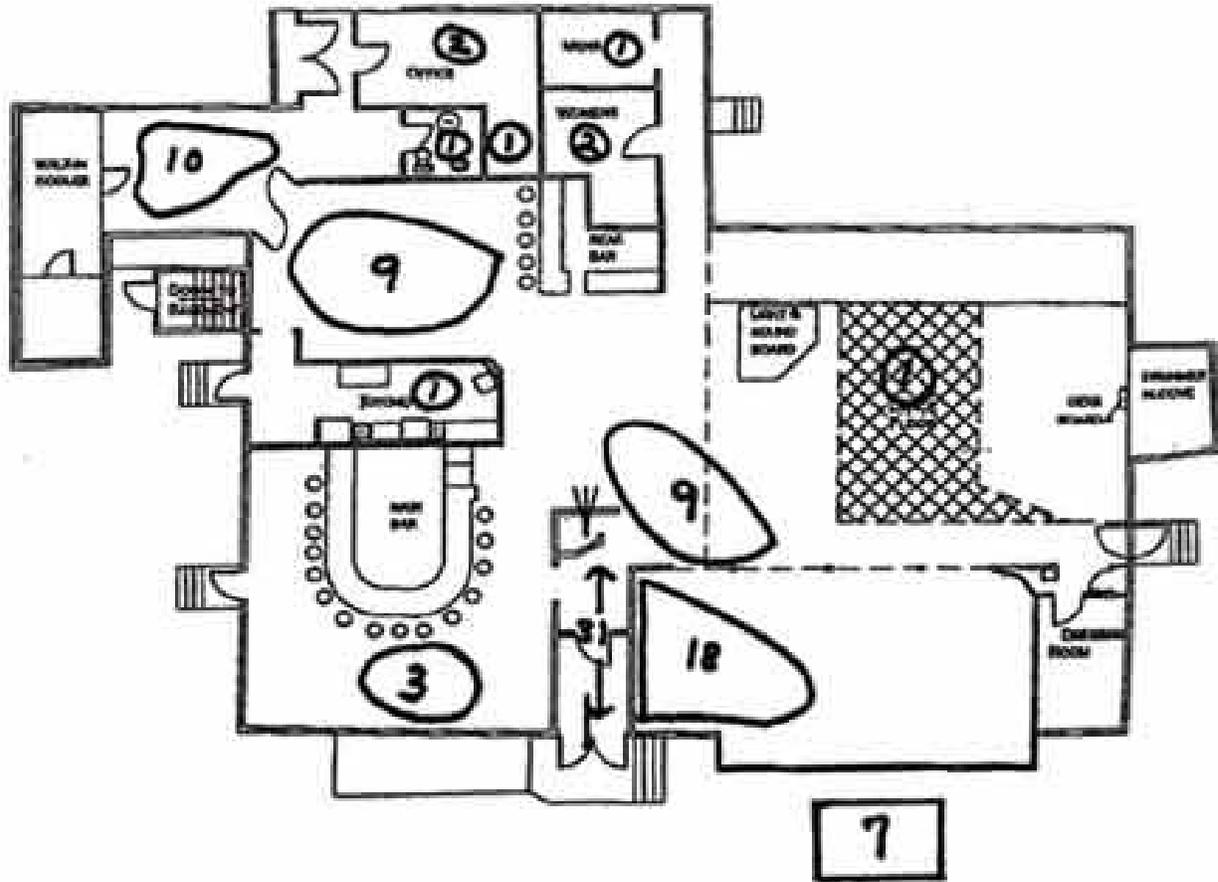
Figure 6-14. Location of Recovered People Who Died at Scene [36]
