NIST NCSTAR 2: Vol. I

Report of the Technical Investigation of The Station Nightclub Fire

June 2005

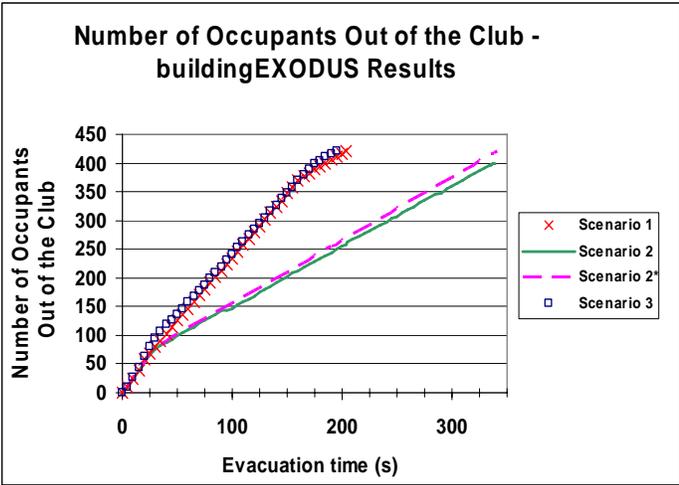
Simulation of egress for different scenarios

Prior to 1-1/2 minutes into the fire, a crowd-crush occurred in the front vestibule which almost entirely disrupted the flow through the main exit. Many people became stuck in the prone position in the exterior double doors.

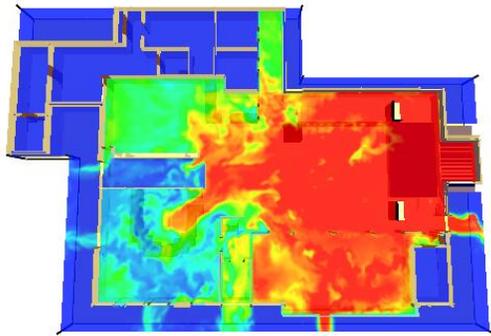
Temperatures 1.5 m (5 ft) above floor 90 seconds after ignition, calculated from computer simulation of full-scale nightclub fire.

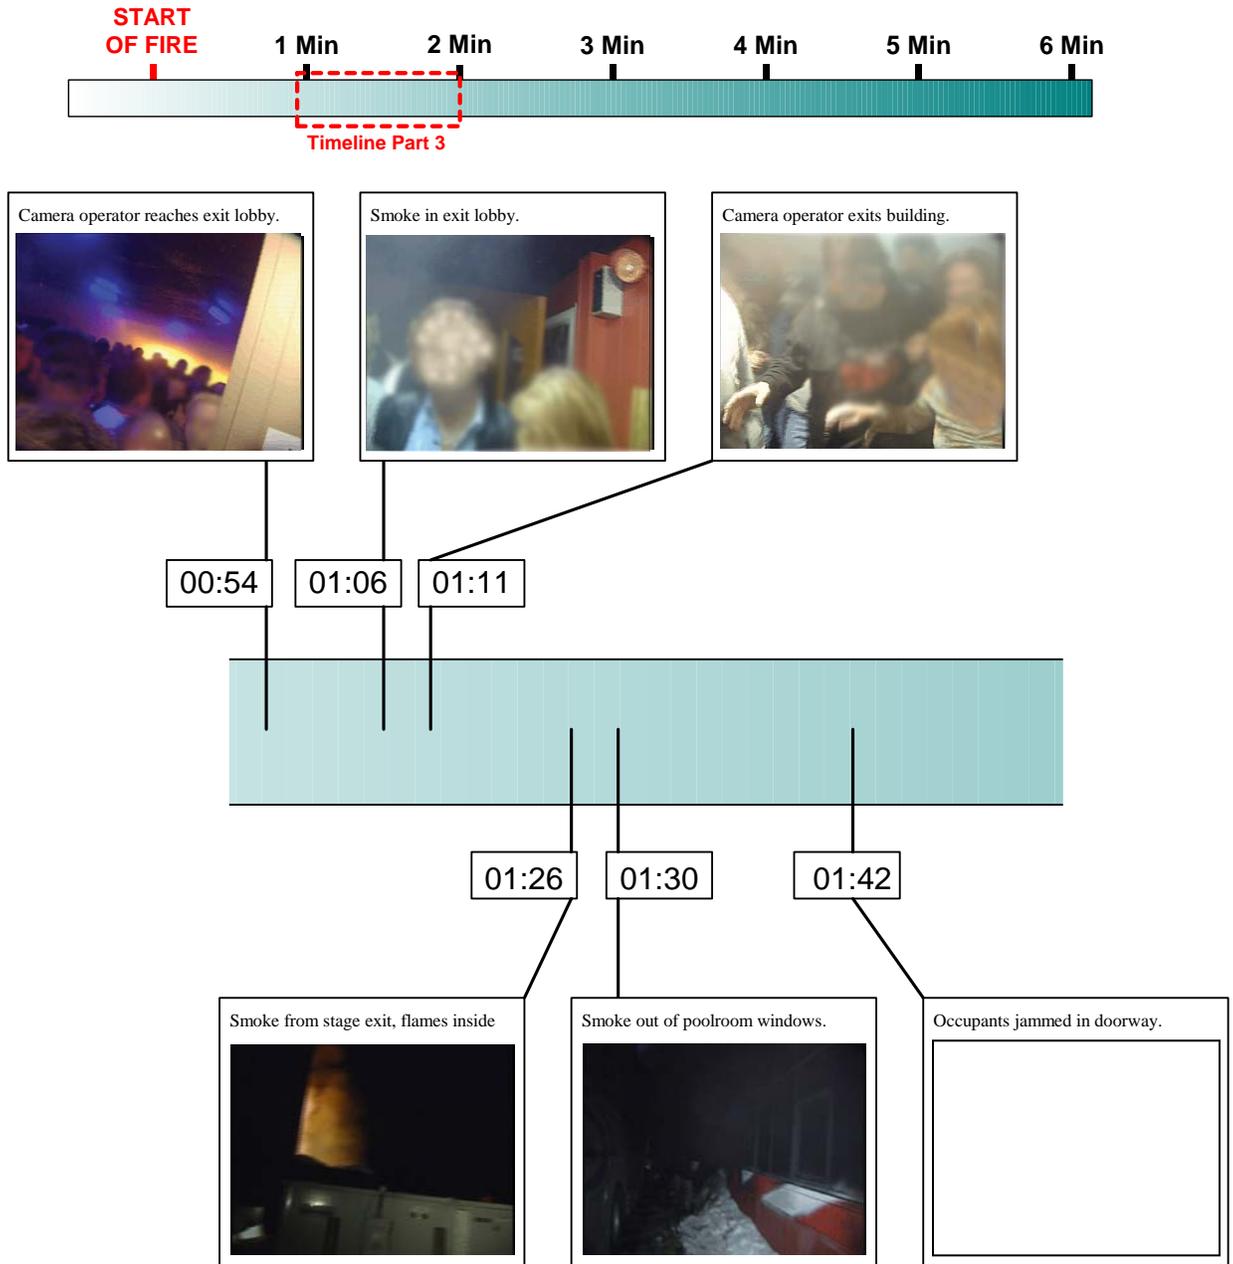
Figure 2-2c. Incident Timeline (50 seconds to 2 minutes after ignition). Video stills copyright © 2003 TVL Broadcasting, Inc. All rights reserved.

The videographer made his way to the exit lobby while continuing to capture the movement of the crowd leaving the area around the dance floor. As seen in Fig. 2-2c, he exited the building at 1 minute 11 seconds (fire time) along with a steady stream of occupants. Sometime estimated to be around 1 minute 30 seconds after ignition of the foam, the front exit became blocked with people, and occupants could be seen breaking windows and escaping from the poolroom/sunroom. The result of the crowd crush at the front exit was captured on the video at 1 minute 42 seconds (Fig. 2-2c). The latest time recorded for an occupant escaping from inside the main bar (through a window) was at 4 minutes 8 seconds; however, people stuck in the front entrance are seen in the video to have escaped as late as 5-1/2 minutes into the fire, just before the fire department ran its first hose line (Fig. 2-2d). (One patron claimed to have been pulled from the bottom of the pile by a firefighter considerably later, but this has not been confirmed by the NIST investigation.)

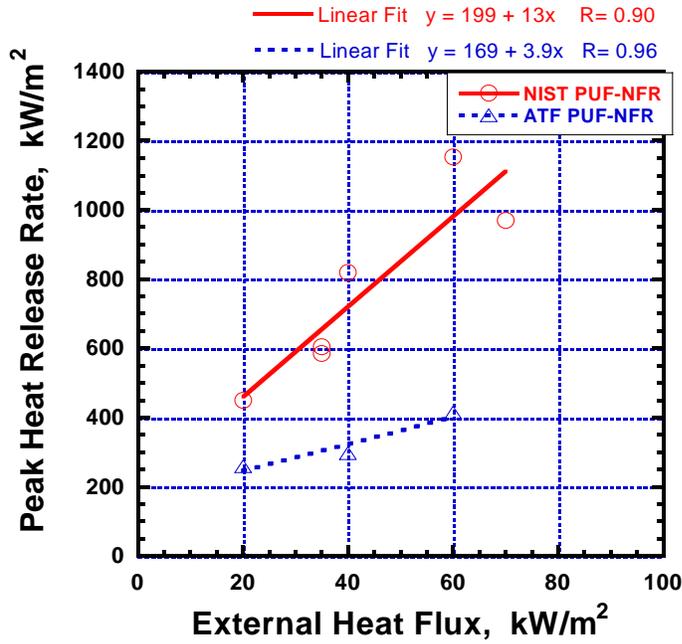
Figure 4-2a. Peak heat release rate versus external heat flux for different polyurethane foams tested at NIST and ATF.

The precise reasons why the polyether foam tested by ATF differed from the behavior of the foams tested by NIST are not clear. (NIST did not have access to the foam from the fire scene tested by ATF.) However, the shorter time necessary for ignition of the ATF foam suggests that the effective value of $k_{p,c}$ was less. It is possible that the behaviors were influenced by the different molecular structure, additives, or manufacturing processes. It is also not clear under what conditions the foam had been stored in the basement of the nightclub or whether it had always been stored in the basement, nor what impact aging or water from fire fighting operations may have had on the foam. Using the properties of either foam, the fire is predicted to spread rapidly, with the foam acting as an ignition source for the wood layer underneath. The contribution from the foam to the total heat release in the fire was much less than from the wood, once the wood was ignited by the burning foam.

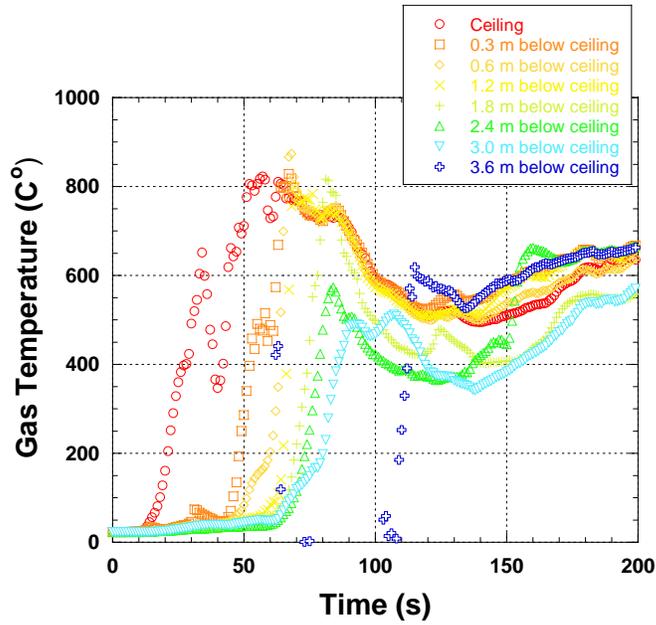
Figure 4-22. Temperatures versus Time for Unsprinklered Mockup Test. Thermocouples positioned on Platform (Location B) from ceiling to platform floor.

For the unsprinklered case, the temperature at the ceiling measured at location B (Fig. 4-22) began to increase within 10 seconds of ignition and continued to increase to over 800 °C in approximately 50 seconds. In less than 60 seconds, the temperature exceeded 50 °C at 1.4 m (4.5 ft) above the floor (2.4 m below the ceiling). The hot gases began to form an upper layer and the layer began to descend; in just over 110 seconds, the temperature at the floor of the platform had increased to over 600 °C.

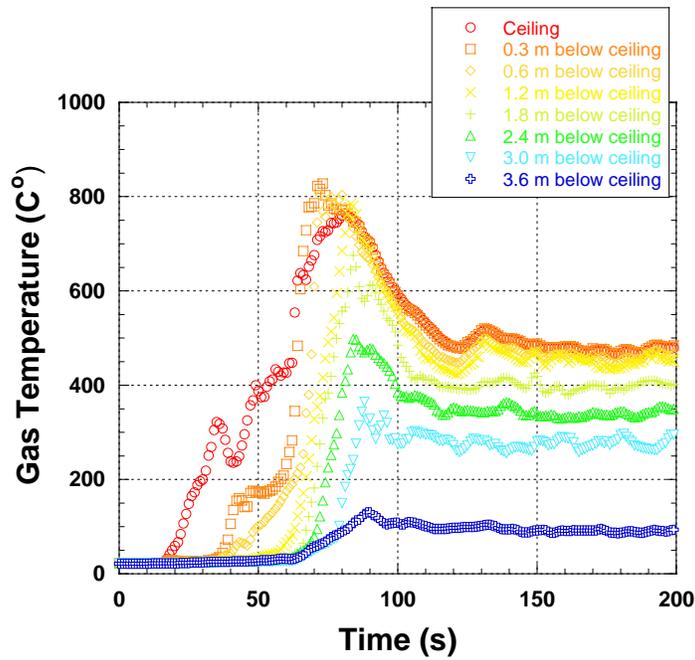
Figure 4-23. Temperatures versus Time for Unsprinklered Mockup Test. Thermocouples positioned on Main Floor (Location C) from ceiling to floor.

The thermocouple array at location C was installed 6.7 m from the foam covered platform wall, 3 m further away from the platform wall than the thermocouples at location B. The temperatures required about 15 seconds longer to begin increasing than those measured at location B, and required approximately 70 seconds to reach peak temperatures of 800 °C. From Fig. 4-23 one can see that the temperatures at 3.6 m below the ceiling did not begin to increase until 60 seconds after ignition and then the temperatures reached peak values of approximately 100 °C in 90 s. The temperatures at location C exceeded 50 °C at the 1.4 m (4.5 ft) above the floor (2.4 m below the ceiling) elevation in less than 70 seconds.

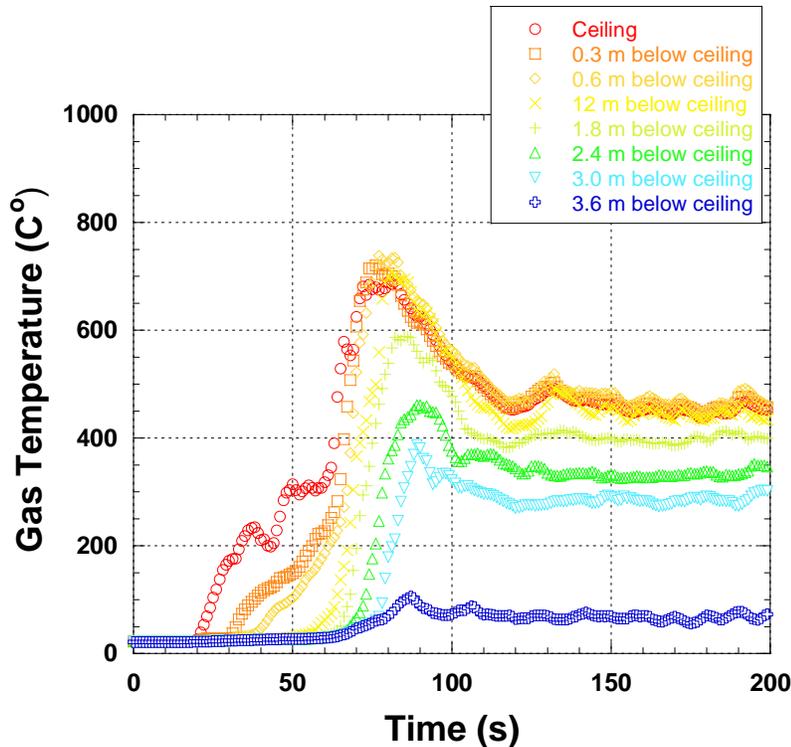
Figure 4-24. Temperatures versus Time for Unsprinklered Mockup Test. Thermocouples positioned on Main Floor (Location D) from ceiling to floor.

The thermocouple array at location D was installed 8.5 m from the foam covered platform wall, an additional 1.8 m further away from the platform wall than the thermocouples at location C. The temperatures began to rise in about 20 seconds (see Fig. 4-24), and required approximately 80 seconds to reach peak temperatures of 700 °C. The temperatures at 3.6 m below the ceiling did not begin to increase until 70 seconds after ignition and reached peak values of approximately 100 °C in 90 s. The temperatures near the floor at location D were about the same as the values recorded at the floor on the platform, Location C.

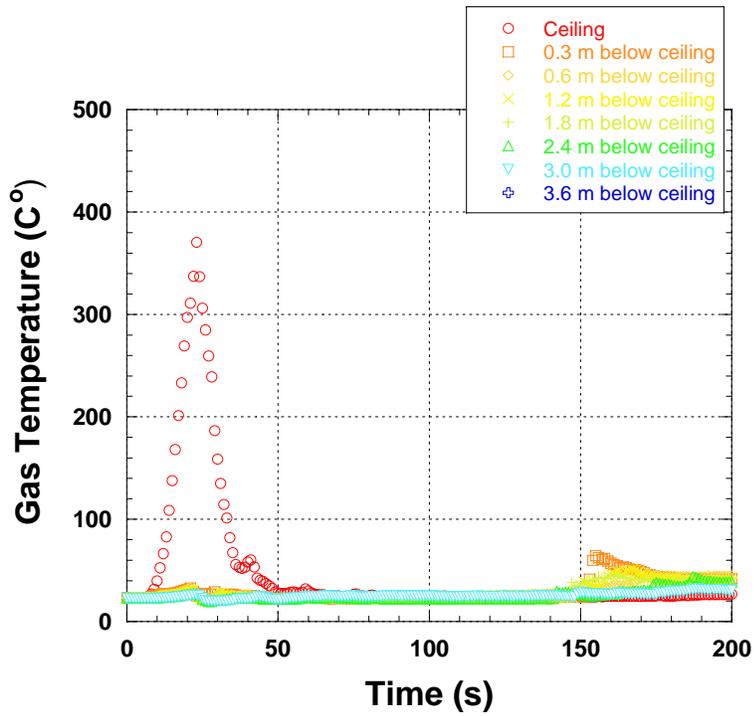
Figure 4-25. Temperatures versus Time for Sprinklered Mockup Test. Thermocouples positioned on Platform (Location B) from ceiling to platform floor.

For the sprinklered test burn, the ceiling thermocouple at location B (on the platform) recorded a peak temperature of 380 °C about 20 seconds after ignition, as can be seen in Fig. 4-25. When the sprinkler activated, the ceiling temperature quickly decreased, dropping to about 20 °C within 40 seconds of ignition. The activation of the sprinklers caused the other thermocouples at lower elevations to record near ambient temperatures throughout the test burn.

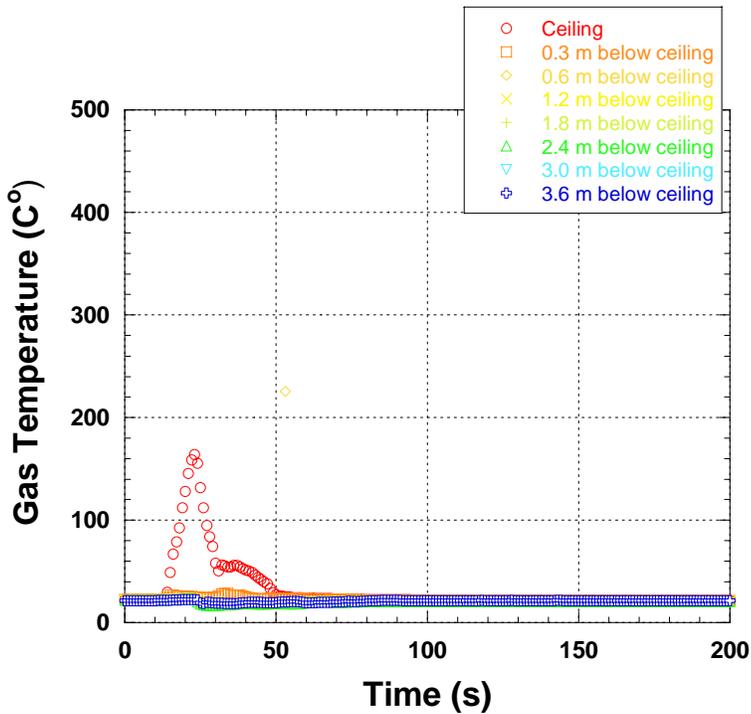
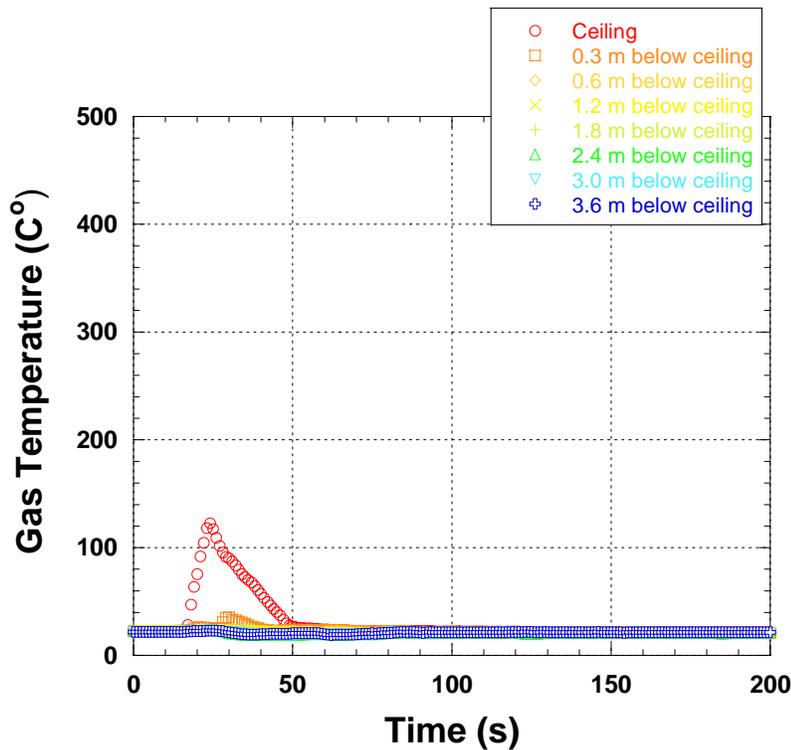
At location C (Fig. 4-26), the ceiling temperatures reached a peak temperature of 170 °C in about 20 seconds and declined to near ambient temperatures within 60 seconds. For location D (Fig. 4-27), the ceiling temperatures reached a peak temperature of 130 °C in about 20 seconds and declined to near ambient temperatures within 60 seconds. Thermocouples at lower elevations for both locations appeared to remain at near ambient temperatures throughout the test.

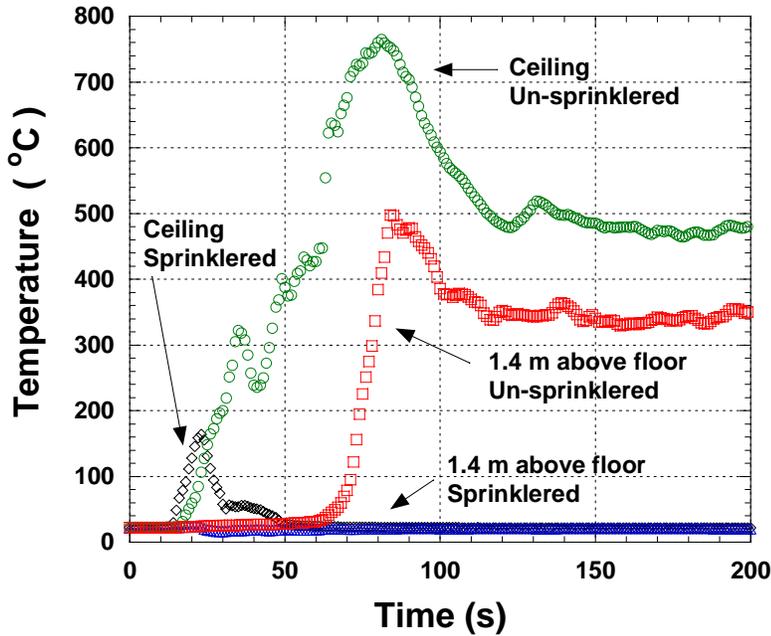
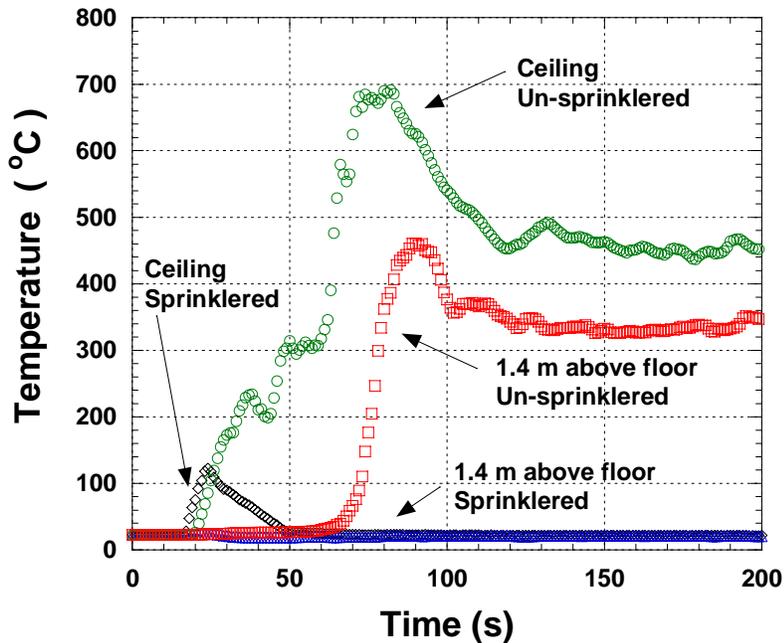
The comparison between the temperatures at the ceiling and 1.4 m above the floor for the sprinklered and unsprinklered experimental data is striking, as demonstrated in Fig. 4-28a for location C and Fig. 4-28b for location D. At 25 seconds, the temperatures at the ceiling were about 175 °C at location C and 125 °C at location D for both experiments, indicative of the fire being properly replicated up to the point when the sprinkler activated. During the next 25 seconds the temperatures throughout the compartment returned to close to ambient conditions in the sprinklered compartment. This compared to a continuing rapid rise in temperatures for the unsprinklered compartment, which reached ceiling temperatures in excess of 300 °C at 50 seconds, and peaks of 700 °C plus in the following 25 seconds. Peak temperatures of 400 °C to 500 °C were reached 1.4 m above the floor for the unsprinklered test; temperatures did not rise at all for the sprinklered compartment at this location.

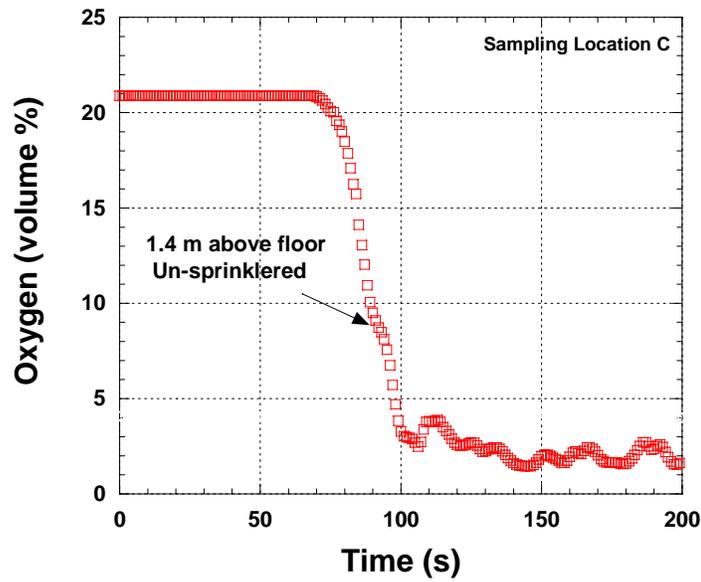
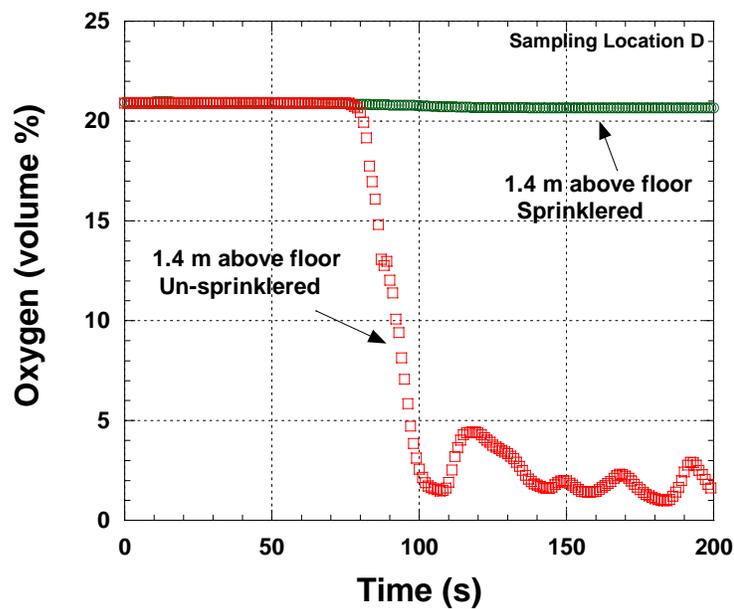
Gas volume fractions versus time are plotted for the unsprinklered and sprinklered tests in Figures 4-30 through 4-35 for O₂, CO and HCN. (Additional gas volume fractions measurements are discussed in Appendix G.) At both locations C and D, oxygen volume fractions did not begin to drop at the 1.4 m elevation until 70 seconds to 80 seconds after ignition for the unsprinklered mock-up experiments. At both locations, the oxygen volume fractions descended to less than 4 % in less than 100 seconds, then fluctuated between 1 % and 4 % . During the sprinklered test burns, the oxygen mole fraction at location D did not appear to drop much below ambient oxygen levels. (A malfunctioning oxygen analyzer prevented the oxygen concentrations from being monitored at location D during the sprinklered burns.)

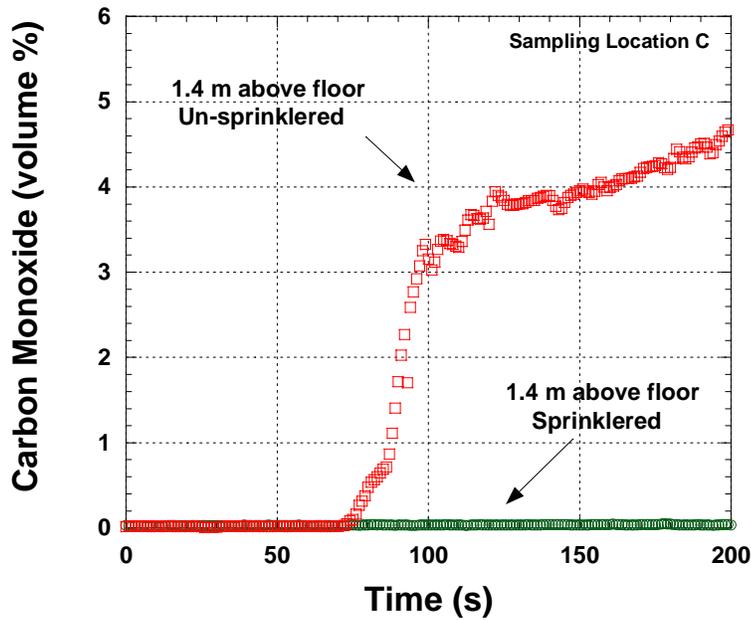
Figure 4-32. Carbon Monoxide Volume Fraction vs Time for Unsprinklered and Sprinklered Mockup Test. Gas Sampling probe positioned on Main Floor (Location C) at 1.4 m (4.5 ft) above floor.

At both locations C and D, volume fractions of carbon monoxide at the 1.4 m elevation did not begin to increase until 70 seconds to 80 seconds after ignition for the unsprinklered mock-up experiments, but then increased to 3 % in the next 20 seconds to 30 seconds and reached 4.5 % by 200 seconds after ignition. During the sprinklered test burns, the carbon monoxide concentration at neither location C nor location D appeared to increase much above ambient levels.

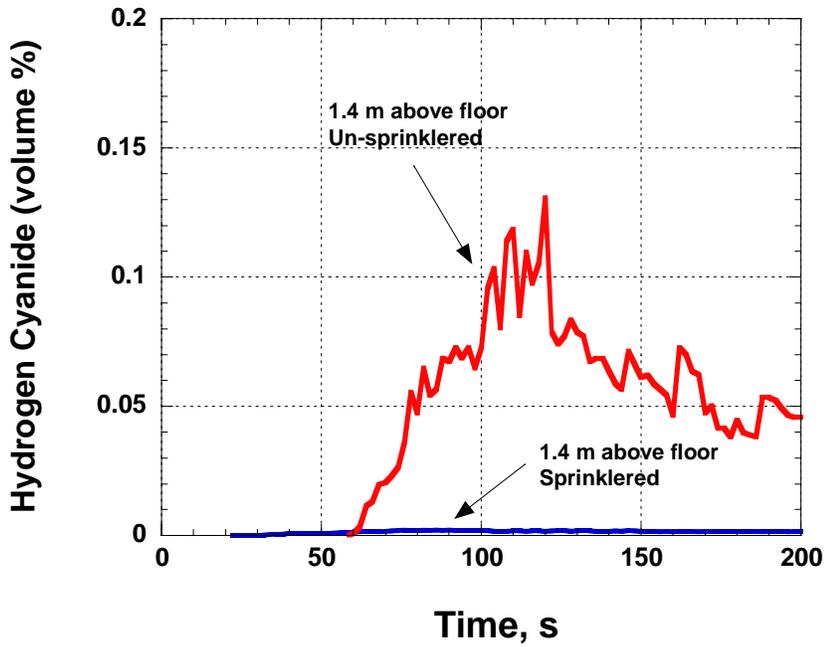
Figure 4-34. Hydrogen Cyanide Volume Fraction vs Time for Unsprinklered and Sprinklered Mockup Test. Gas Sampling probe positioned on Main Floor (Location C) at 1.4 m (4.5 ft) above floor.

The volume fractions of hydrogen cyanide at the 1.4 m elevation began to increase 60 seconds after ignition for the unsprinklered mockup experiments. At location C, the HCN reached its peak value of 0.13 % in 120 seconds. The HCN increased slightly faster at location D, where it reached a peak volume fraction of 0.17 % in about 90 s. During the sprinklered test burns, the hydrogen cyanide concentration at locations C and D were barely above the measurable limit.

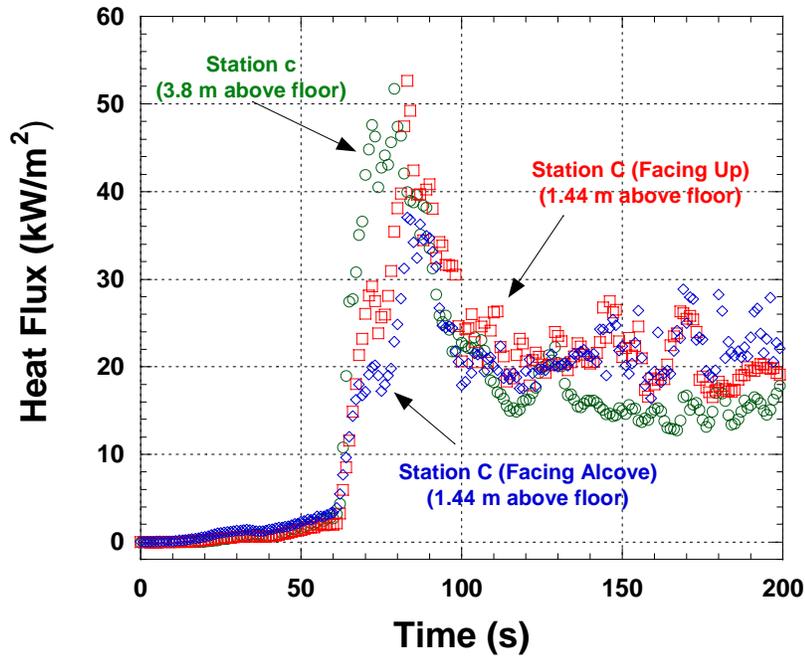
Figure 4- 37. Heat Fluxes versus time for unsprinklered mockup test. Radiometer positioned flush with ceiling (3.8 m above floor); heat flux gauges facing up (1.44 m above floor), and facing alcove (1.44 m above floor) at sampling location C.

For the unsprinklered compartment test, the output of the thermal radiation and total heat fluxes for the radiometer and heat flux gauges at locations C and D are shown in Fig. 4-37 and Fig 4-38. At location C, peak fluxes in excess of 50 kW/m² were reached about 70 seconds after ignition. Peak fluxes at location D were about 20 % lower than location C. At 100 seconds after ignition, radiation and heat flux at

location C and the heat flux at location D decreased significantly to 20 kW/m^2 and appeared to remain relatively constant at both locations. The radiometer in the ceiling at location D dropped to 10 kW/m^2 before becoming relatively steady. (Additional plots of heat flux are shown and discussed in App. G.)

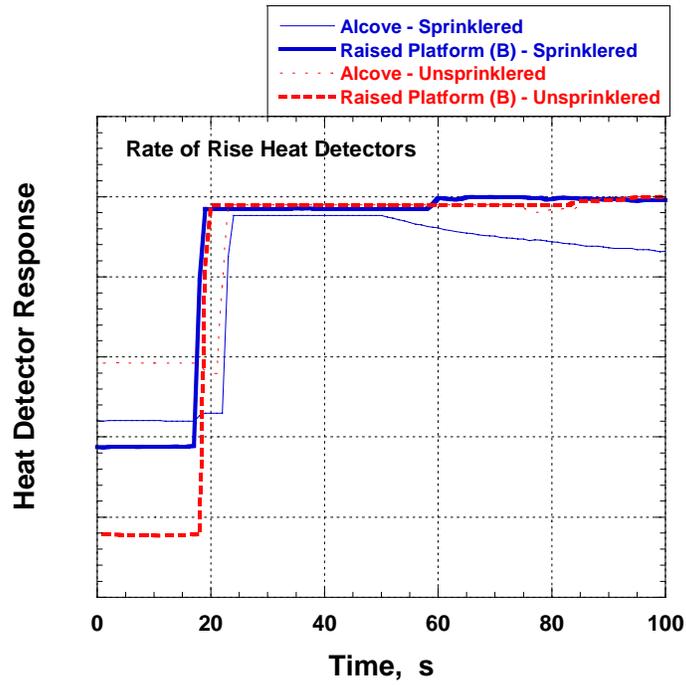
Figure 4- 39. Response of Rate of Rise Heat Detectors versus Time for Unsprinklered and Sprinklered Mockup. Detectors located in Alcove and at Location B.

The responses of rate of rise heat detectors and fixed temperature detectors are plotted in Fig. 4-39 and Fig. 4-40, respectively. For both unsprinklered and sprinklered test burns, each of the rate of rise detectors activated in less than 20 seconds. Only in the unsprinklered experiments did the fixed temperature detectors activate. The fixed temperature detector in the alcove activated in about 20 seconds while the fixed temperature detector above the platform required almost 40 seconds to respond.

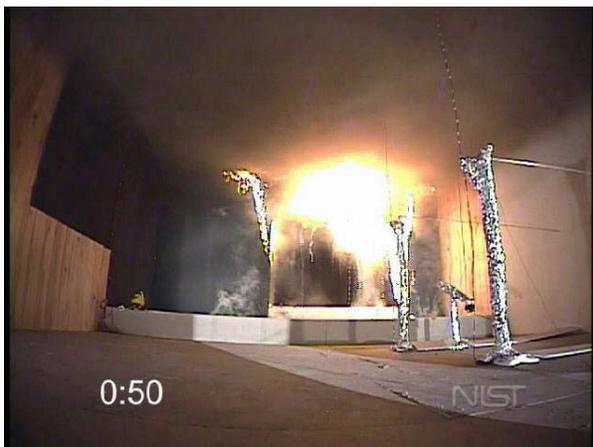
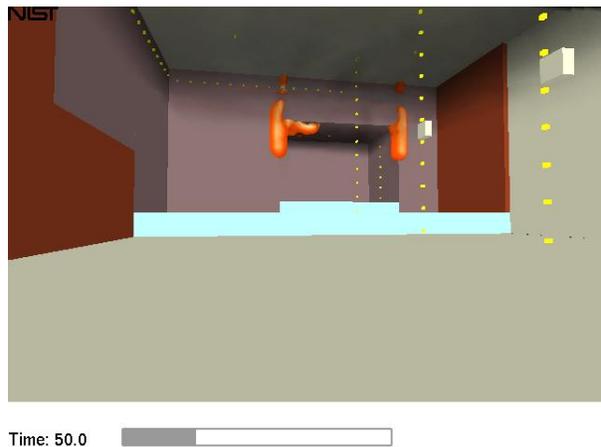
Figure 5-7. Ceiling of alcove fully involved in fire, $t = 50$ seconds after ignition.

Figure 5-7, has images captured at 50 seconds after ignition. In the experiment, it appears that the entire ceiling of the alcove is burning, as well as the area of the platform wall above the opening to the alcove. There is also more smoke from drop-down of the burning foam onto the carpet, both in the alcove and on the platform. In the simulation, the flames have moved into the alcove and are spreading across the ceiling. In both images, the smoke or hot gas layer has developed across the ceiling of the enclosure.

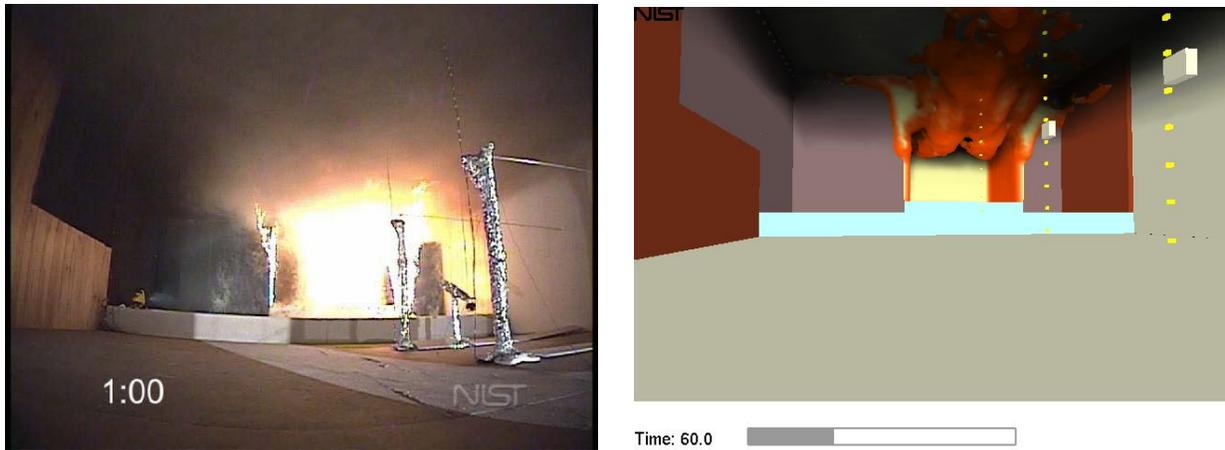
In Figure 5-8, the ceiling and the walls of the alcove have become fully involved with fire in both of the images. At 60 seconds after ignition, flashover has already occurred in the experiment and flashover is about to occur in the simulation. In both cases, flames are extending out of the alcove across the ceiling and the smoke layer has become thicker and darker.

Figure 5-8. Flashover has occurred in alcove area, $t = 60$ seconds after ignition.

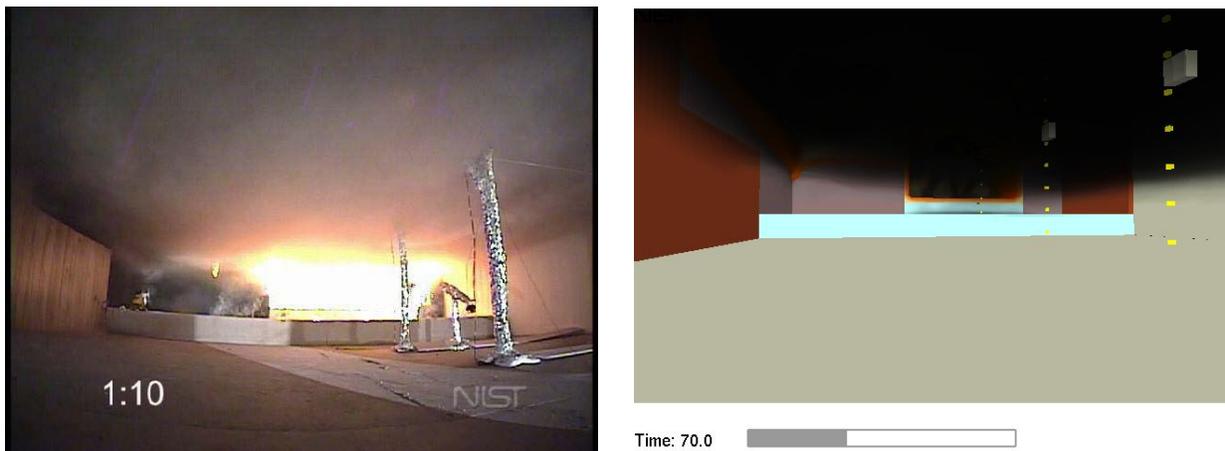
Figure 5-9. Smoke layer has dropped to 1.5 m above floor, $t = 70$ seconds after ignition.

The images in Figure 5-9 show a significant increase in the amount of the smoke in the enclosure. The smoke layer has descended to within 1.5 m (5 ft) of the floor. The flames have spread along the wall behind the platform and can be seen at the lower edge of the smoke layer in both the video frame and the image from the simulation. The smoke in the experiment appears lighter in color than it actually is due to light that is being reflected from floor level halogen lights that were used to improve the visibility for the video cameras.

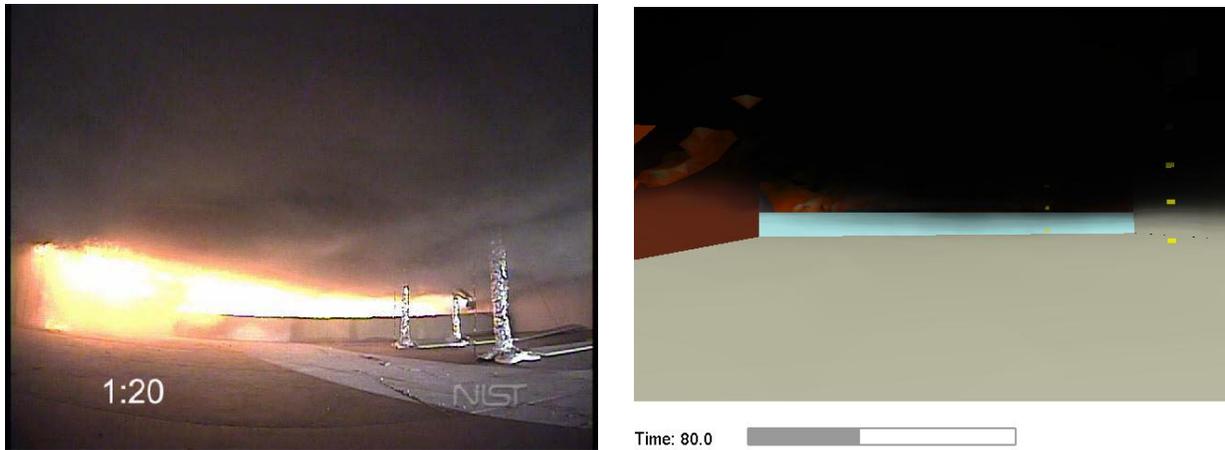
The fire continues to grow in both the experiment and the simulation as shown in Figure 5-10. The smoke layer has continued to descend. The interface height of the smoke layer is approximately 0.75 m (2.5 ft) above the floor at 80 seconds after ignition for both the experiment and the simulation. Both images also show the flame extension on the left wall of the enclosure. The upper portion of the left wall near the platform had foam installed over the paneling.

Figure 5-10. Fire continues to spread, $t = 80$ seconds after ignition.

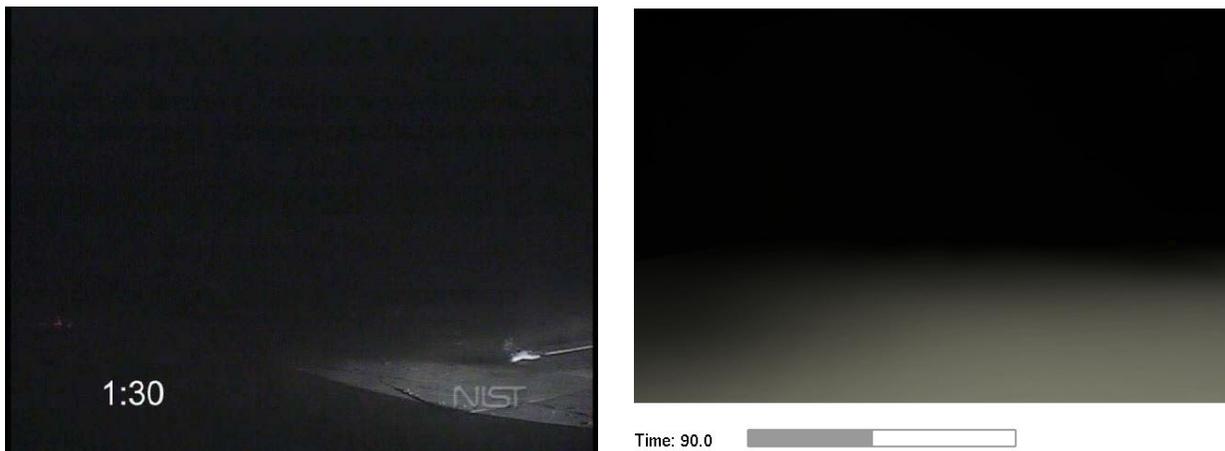
Figure 5-11. Visibility lost, $t = 90$ seconds after ignition.

The last set of images, Figure 5-11 demonstrate that most of the visibility in the enclosure has been lost due to smoke filling. A small layer of clear area can be seen near the floor in both the experiment and the simulation. This is due to fresh air being drawn into the fire enclosure through the open doorway.

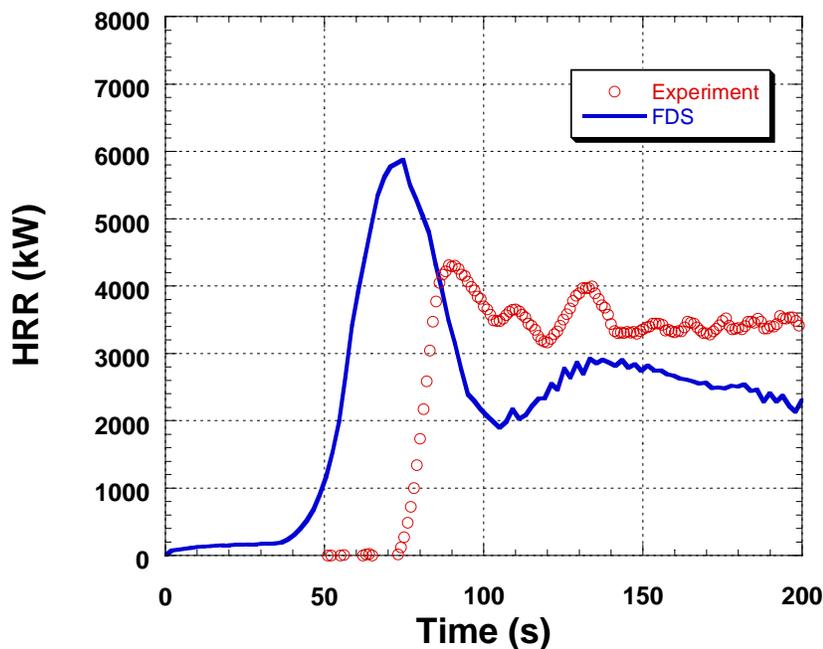
Figure 5-12 compares the measured heat release rate leaving the door of the experiment (based upon oxygen consumption) to the heat release rate from the fire within the compartment as predicted by FDS. For fires burning in the open under the laboratory hood, the thermal power measured by the oxygen depletion calorimeter is equal to the heat release rate from the fire. However, for a fire within an enclosure, the effluent from the room is a mixed average of the upper layer gases, and does not represent the instantaneous heat release rate of the fire. Smoke did not exit the compartment doorway until approximately 60 seconds after ignition. This means that a direct comparison between the experimental measurements and the numerical predictions cannot be made because the oxygen depletion calorimeter does not respond to a fire within an enclosure until the combustion products have had time to exit the door and become entrained into the hood. The heat release rate predicted by FDS in Fig. 5-12 represents the instantaneous heat release throughout the room. The heat release rate reaches a peak of

Figure 5-12. Power generated in experiment as measured outside of doorway, compared to FDS simulation of heat release rate from fire within compartment.

approximately 6 MW about 70 seconds into the simulation, 20 seconds prior to the peak in thermal power measured in the oxygen depletion calorimeter. Both curves approach 3000 kW \pm 300 kW approximately 150 seconds into the fire, again consistent with a ventilation-limited condition. The heat release rates diverge at longer times as the model consumes the remaining interior finish fuels while the physical fire continues to burn at a reduced rate into the wood supporting the platform and walls. When the areas under the heat release rate curves were integrated, the resulting energies were found to agree within 10 %.

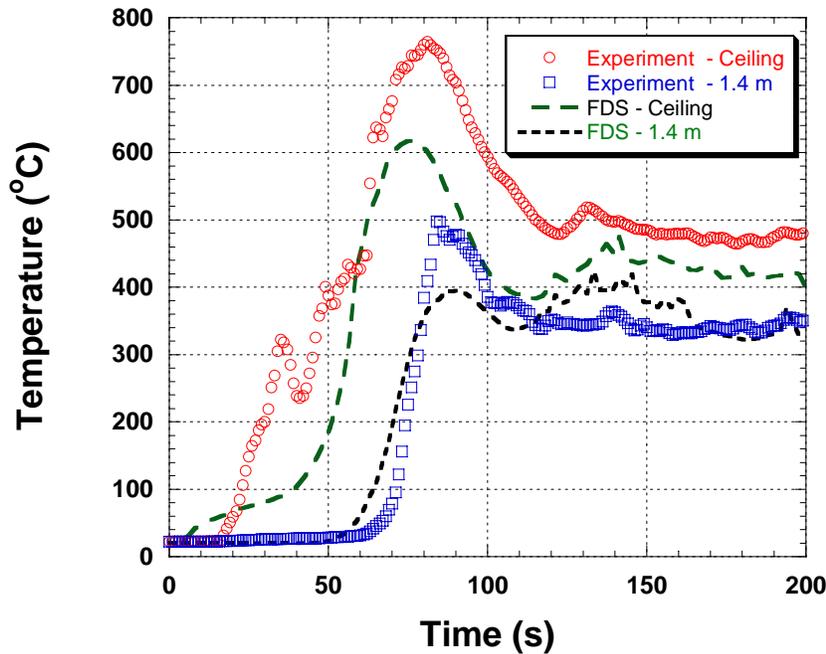
Figure 5-13. Temperature comparison between the un-sprinklered fire experiment and the FDS simulation at Station C.

Figure 5-13 is a comparison of the temperatures predicted and measured 25 mm below the ceiling and 1.4 m above the floor at the thermocouple array located at Station C (4.25 m west of the door opening or 1.7 m from the platform). The FDS output has been smoothed by applying a Stineman function (a geometric weight applied to the current point \pm 10 % of the data range). The temperature data show reasonable agreement with the predictions, including an overshoot followed by a leveling off as the fire reaches a ventilation limit. The temperatures near the ceiling increase faster in the test; conversely, the lower level temperatures increase at a slower rate in the test.

Note that, unlike the heat release rate, the temperature measurements respond to the local environment within a second; hence, the experimental temperatures and FDS predictions can be compared directly. Initially, the experimental measurements near the ceiling increase more rapidly than predicted. This is probably due to the strong transverse temperature gradients associated with the ceiling jets created early in the fire (see Fig. 5-5), where small differences in position between the experiment and simulation can have a large change in temperature. The simulated thermocouple temperatures are temperatures averaged over the grid cell volume(s) that they are associated with, which results in differences in positions between the experimental point measurement and the FDS output. The peak temperatures for the experiment and the simulation occur within 5 seconds of each other.

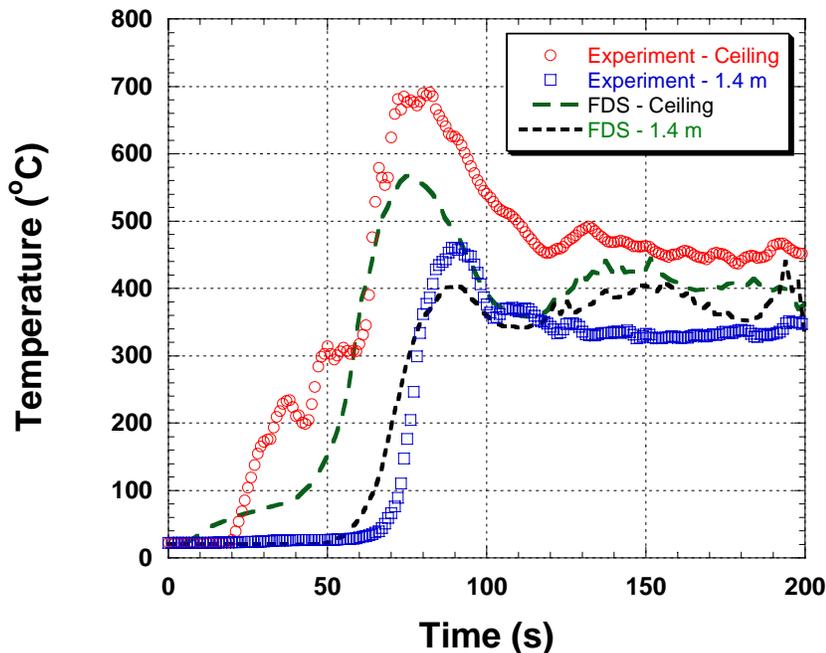
Figure 5-14 is a comparison of the temperatures predicted and measured 25 mm below the ceiling and 1.4 m above the floor at the thermocouple array located at Station D (2.35 m west of the door opening). Similar to the previous figure, the temperature data show reasonable agreement with the predictions. The trends are also similar and both of the measured temperatures and the predictions exhibit a reduction in peak temperatures relative to the values from Station C that is located approximately 2 m closer to the platform.

Figure 5-14. Temperature comparison between the un-sprinklered fire experiment and the FDS simulation at Station D.

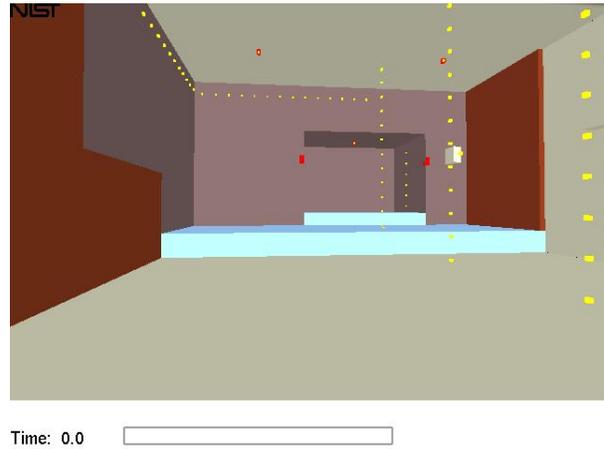
Figure 5-19. Ignition at the corners of the alcove, t = 0 seconds.

sprinkler activation. Figures 5-19 through 5-21 show a very similar progression in fire growth as the unsprinklered case for both the experiment and the FDS simulation between ignition and 20 seconds after ignition. Figure 5-22 was captured at 25 seconds after ignition, approximately 1 second after the first sprinkler activated in both the experiment and the simulation. With the experiment, the impact of the sprinkler can be seen as the fire on the right side of the platform wall is suppressed. In FDS the flame height on the right side of the alcove can be seen to be reduced.

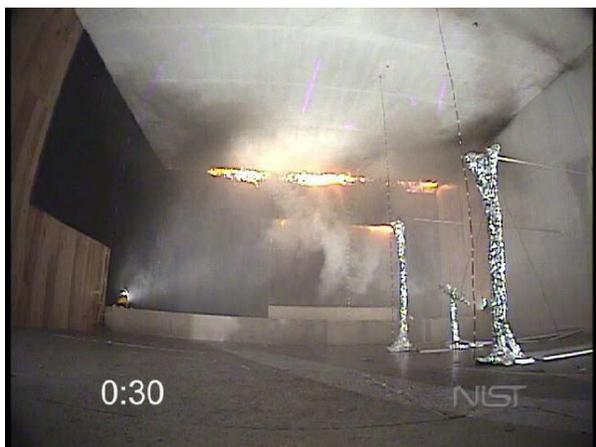
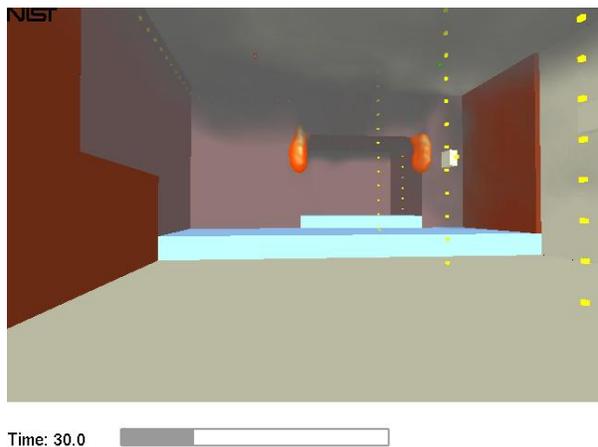
Figure 5-23. Third sprinkler operating in experiment, $t = 30$ seconds after ignition.

By 30 seconds (see Fig. 5-23) the effect of both of the sprinklers above the platform operating as well as the sprinkler in the alcove is apparent. Burning continues at the intersection of the platform wall and the ceiling. This area is above where the water spray is hitting the wall. Also notice the flames on the ceiling of the alcove. This area is shielded from the water spray of the two sprinklers. The smoke being pushed out of the alcove is due to the activation of the sprinkler on the ceiling of the alcove. In the simulation, only one sprinkler is operating at this time. The fire growth on the right side of the alcove has been limited by the single sprinkler.

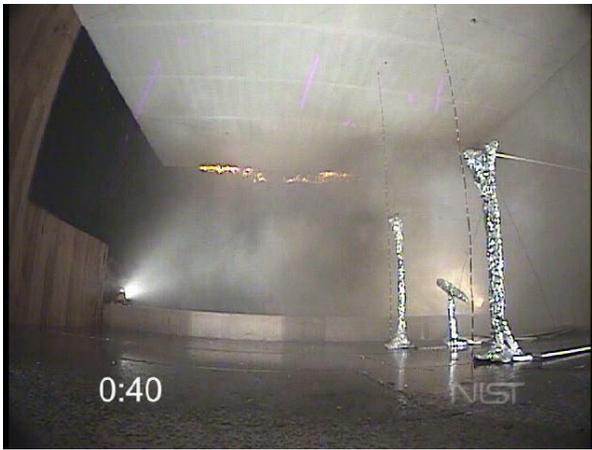
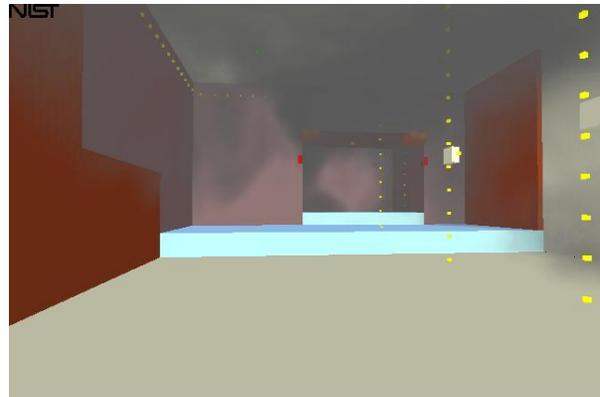
Figure 5-24. Suppression with three sprinklers operating in each case, t = 40 seconds after ignition.

By 40 seconds after ignition, three sprinklers in the experiment and in the simulation have activated. The video frame in Figure 5-24 shows that the fire in the alcove has been suppressed and that the burning above the water line on the platform wall continues. With three sprinklers operating in FDS, the water spray is significantly reducing the visible flames. The flames on the platform wall have been suppressed. However, there are still flames visible at the intersections of the alcove ceiling and the alcove walls on both sides of the alcove. These areas are shielded from the water spray of the sprinklers over the platform and they are above the water impact line from the sprinkler in the alcove.

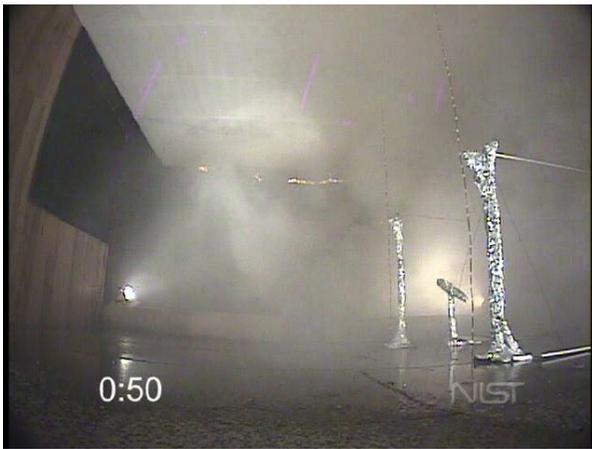
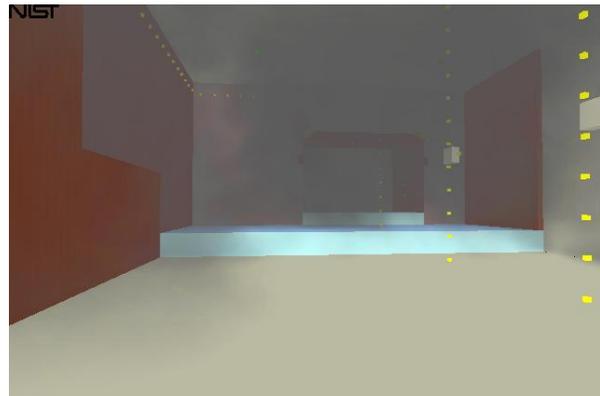
Figure 5-25. Fire suppression continues in both the experiment and the simulation, t = 50 seconds after ignition.

Figures 5-25 through 5-27 show continued fire suppression for both the experiment and the simulation. In both cases some flames exist in the ceiling area of the alcove. But clearly the rate of fire growth and the resulting hazard development has been reduced significantly when compared with the unsprinklered case.

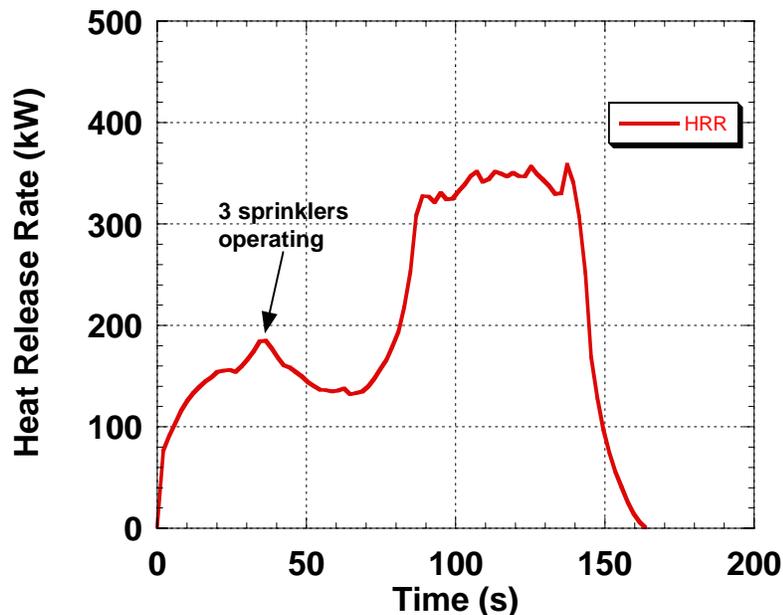
Figure 5-28. FDS predicted heat release rate for the sprinklered case.

Figure 5-28 shows the FDS predicted heat release rate for the sprinklered enclosure. The experiment failed to produce enough combustion gases for the oxygen depletion calorimeter to measure a heat release rate. This was due to the rapid sprinkler activation, the effective fire suppression and the large volume of the enclosure. This graph demonstrates that in the simulation the fire grew after the activation of the third sprinkler (all were operating by 36 seconds). The decrease in HRR at approximately 140 seconds is when the shielded (dry) foam on the alcove ceiling burns itself out. In the experiment, foam above the line of water impact on the walls and the ceiling continued to burn after sprinkler activation as was shown in Figures 5-24 through 5-26.
