NIST NCSTAR 2: Vol. I

Report of the Technical Investigation of The Station Nightclub Fire

June 2005

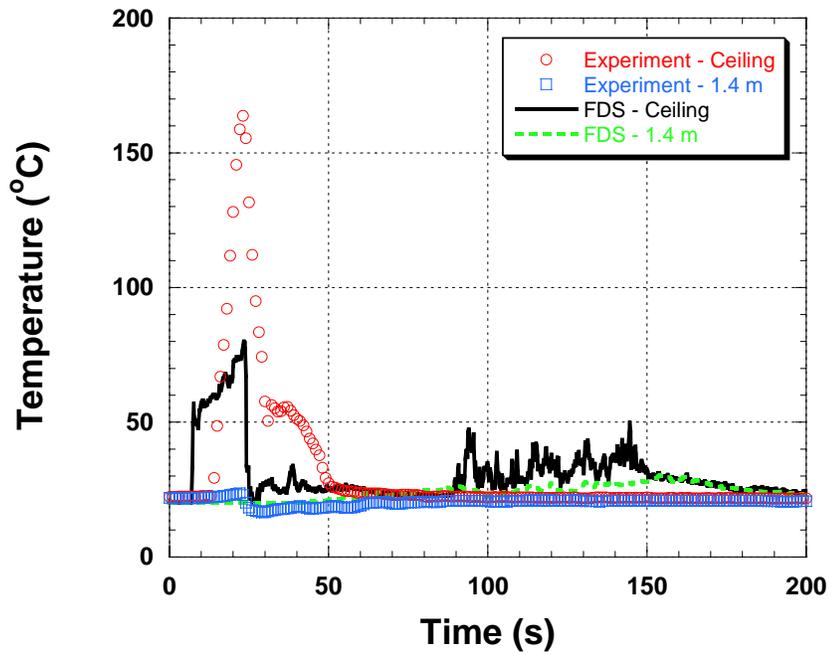
Figure 5-29. Temperature comparison between the sprinklered fire experiment and the FDS simulation at Station C.

The comparison of the temperatures at Stations C and D are shown in Figures 5-29 and 5-30. In both cases FDS under predicts the temperatures near the ceiling. The FDS predictions in these two graphs have not been smoothed in order to show that the peak values near the ceiling are very close to the sprinkler activation temperature of 74 °C. Typically the temperature of the fire gases surrounding a sprinkler at the time of activation is approximately twice the listed temperature.

Due to the continued burning of foam on the ceiling of the alcove prior to complete extinguishment, the temperature in the simulated enclosure increases over the experimental temperatures. However, at the 1.4 m level above the floor the temperature never exceeds 35 °C (95 °F). This is well within the temperature tenability range.

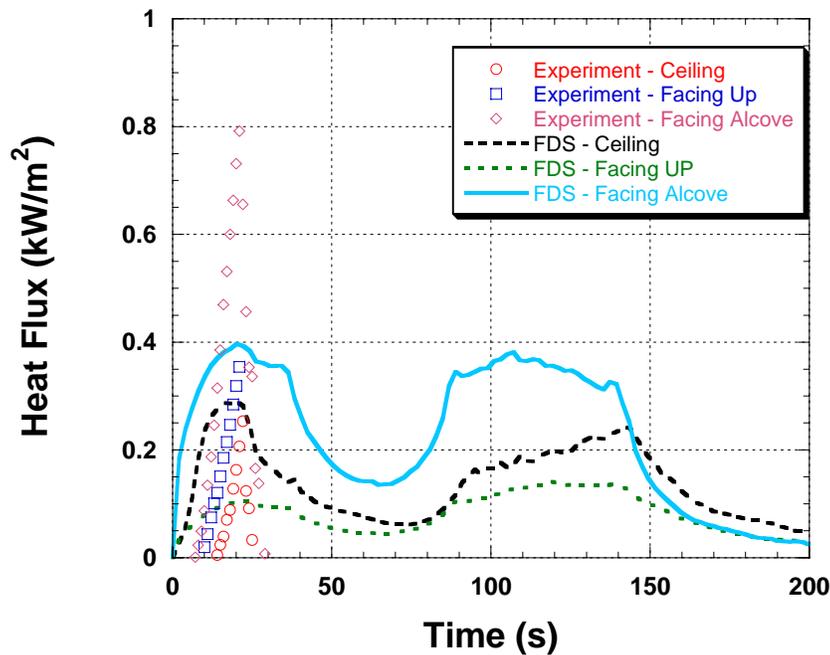
Figure 5-31. Heat flux comparison between the sprinklered fire experiment and the FDS simulation at Station C.

The comparison of the measured heat flux with the calculated heat flux is shown in Figures 5-31 and 5-32. Due to the limited fire growth and significant cooling by the water all of the heat flux values are less than 1 kW/m^2 . One notable difference between the experiment and the simulation is after the sprinklers activate in the experiment, the measured heat flux goes to zero, while in the simulation small values heat flux energy continue to be shown.

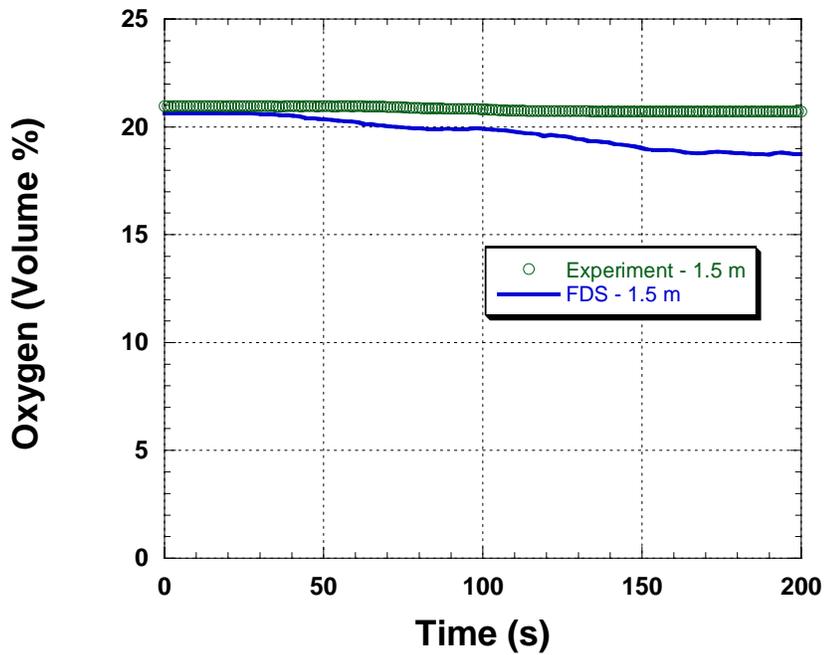
Figure 33. Oxygen volume fraction comparison between the sprinklered fire experiment and the FDS simulation at approximately 1.5 m above the floor at Station C.

Figure 5-33 exhibits the comparison of the measured and predicted oxygen concentrations at Station C. The measured oxygen concentration shows only a slight decrease during the 200 seconds, while the simulation shows a decrease of approximately 2 percent. This may be due to the continued burning of the foam along the ceiling of the alcove that is taking place in the simulation of the experiment.

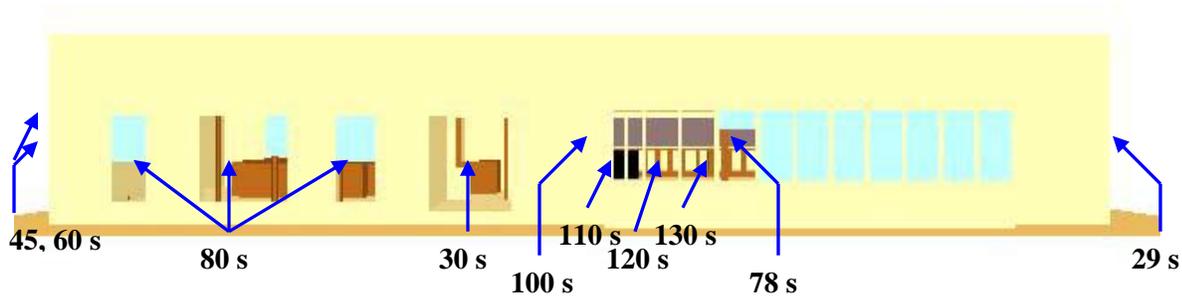
Figure 5-41. Visualization of Opening Times

The structure's doors and windows were opened during the simulation based on estimations from the WPRI video. The first door to open was the door adjacent to the platform. This door was observed opening in the video 29 seconds after ignition. The front double door was assumed to open shortly after the stage door at 30 seconds. This time was selected due to the crowd beginning to notice the fire and to move toward the front door. The side door near the main bar was opened at 45 seconds and the side door in the kitchen was opened at 60 seconds. These times were estimated by the crowd movement seen in the video and the remoteness of the doorways from the stage area.

At 78 seconds, the lower portion of one of the bay windows was removed. This appeared to occur as the cameraman passes by on his way to the rear of the structure. Portions of the windows located on the front of the structure, left of the main entrance were removed at 80 seconds. This included the lower half of each of the matching windows next to the large window in the center, the entire large window in the center, all of the thin window to its left and the lower half of the thin window to its right. Finally, more sections of the bay window, surrounding the portion that was removed at 78 seconds, were removed between 100 and 130 seconds. The side bay window facing the main entrance was seen open in the WPRI video and the three other windows between the side window and the lower portion of the window were removed at 78 seconds based on the sounds heard in the video. Vent opening times are summarized in Table 5-6 and visualized in Figure 5-41.

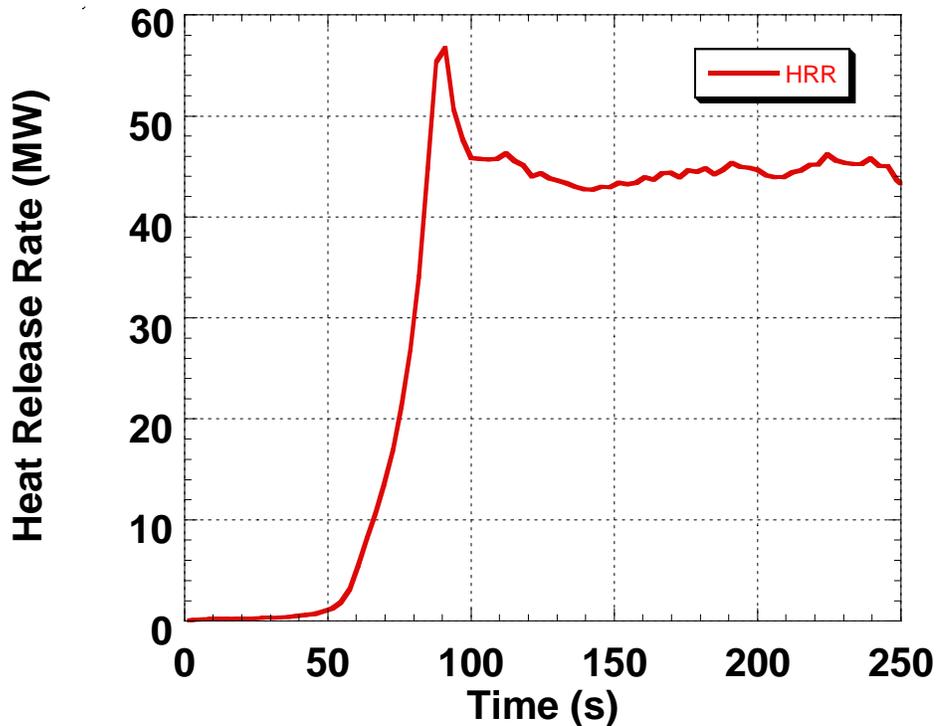
Figure 5-42. Total Heat Released in Building Fire Simulation as a Function of Time

The total heat released in the fire is plotted in Figure 5-42. The graph shows that after the alcove became fully involved with fire, at approximately 50 to 60 seconds, the heat release rate increased from approximately 2 MW to 54 MW in less than 50 seconds. Hence the rate of increase was more than 1 MW per second. As the fire spread throughout the structure and the fire became oxygen limited the heat release rate became steady at approximately 45 MW for approximately 150 seconds. After that time, the simulation began to deplete the fuel contained in the interior finish materials. The fire in the actual nightclub had spread into the structure and burned in and through areas of the roof and walls by this time. The simulation only provided fuel based on the interior finish and did not account for fuel being provided by structural elements and materials in building outer envelope.

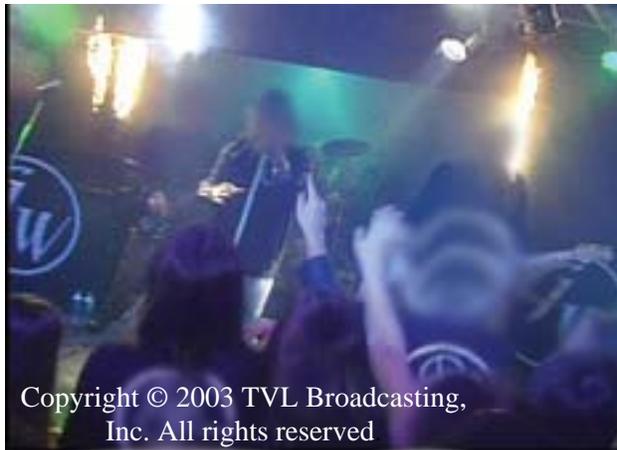
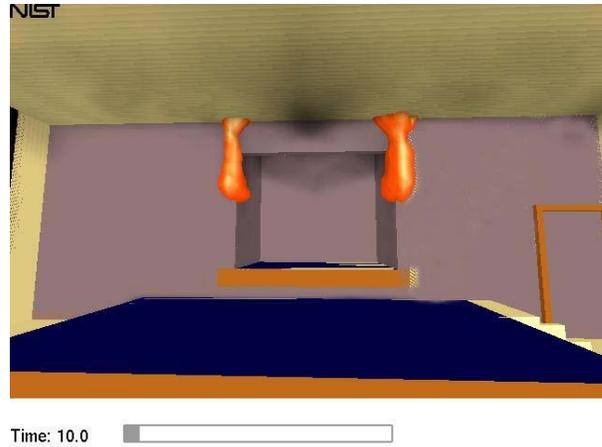
Figure 5-43. Initial growth of fire on foam at corner of the alcove (10 seconds)

The images from the video in Figures 5-43 and 5-44 capture the initial state of the fires on each side of the platform shortly after the gerb discharge had stopped. At 10 seconds after ignition, the fire can be seen burning on two surfaces at each of the corners; this is also considered in the simulation with the placement of the ignition vents on both sides of the corner. In both the simulation and the actual incident the flames impinge on the ceiling within 20 seconds after ignition.

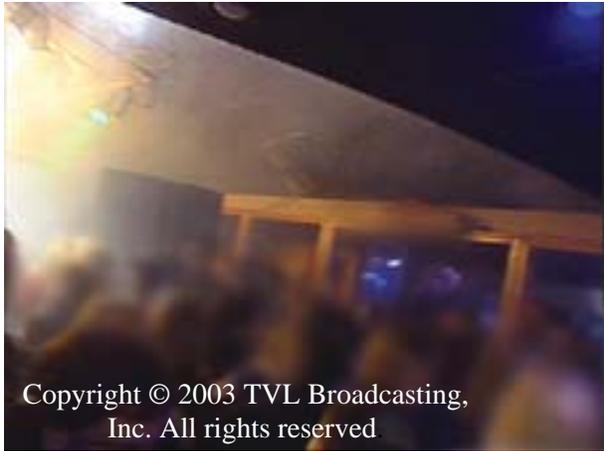
At 23 seconds after ignition, Figure 5-45, the videographer has begun to move toward the exit as have many in the crowd. Notice that many people are still facing the platform. The fire continued to grow and smoke has collected in the raised ceiling area over the dance floor. The smoke filling can be seen in the image from the simulation. (Note the black rectangular image on the floor is representative of the speaker cabinet, whereas the boundaries of the smoke layer are irregular.) At 53 seconds after ignition, the flames have grown and spread along the platform wall and into the alcove as shown in video image in Figure 5-46. In addition, the smoke is spreading across the lower level ceiling area toward the main exit. The flames have spread in the simulation as well and smoke is beginning to spill over from the dance floor area towards the exits and the main bar room, although it takes a few more seconds into the simulation for this to occur. Again the black rectangular objects on the floor are representative of speaker cabinets (near the platform) and the sound and lighting board (left side).

Figure 5-45. Videographer backing away from platform (23 seconds)

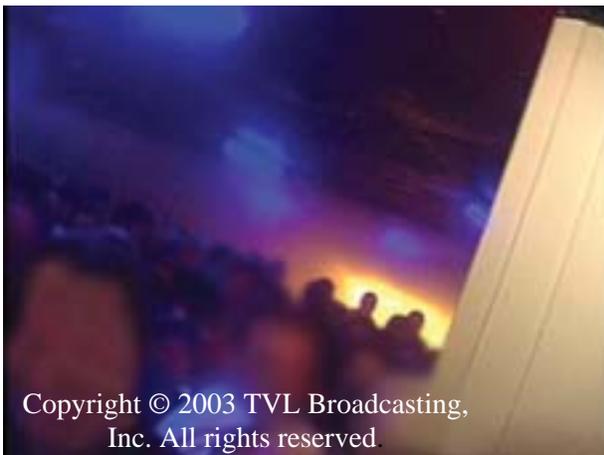
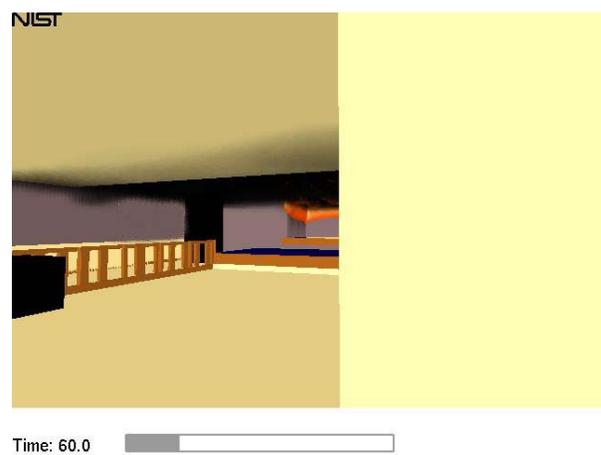
Figure 5-46. Smoke beginning to roll across ceiling (video 53 seconds, simulation 60 seconds)

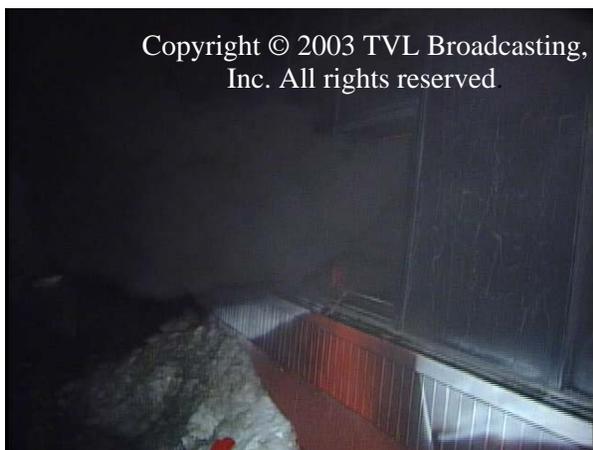
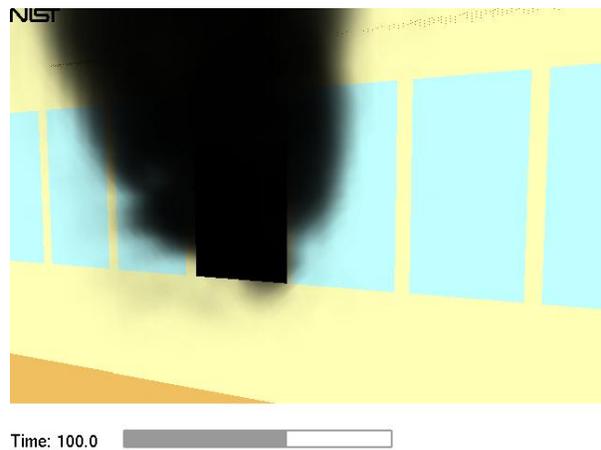
The videographer had exited the nightclub at approximately 70 seconds and headed toward the stage door. He then returns toward the main entrance and attempts to pass between the nightclub and the bus when he encounters a plume of black smoke pushing out of one of the window vents in the sunroom. The image from the simulation also shows a similar view. At approximately 110 seconds after ignition, smoke is flowing from the main entrance; the image from the simulation is given in Figure 5-48. The model did not account for people blocking the air flow into the doorway.

Figure 5-47. Smoke billowing outside from broken sunroom window (100 seconds)

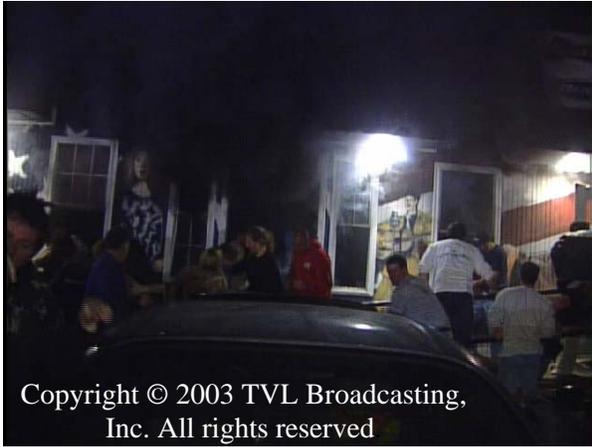
The Smokeview image in Figure 5-49 shows the smoke flow from the front door at 160 seconds after ignition in the simulation. In Figure 5-50, the simulated smoke flow from the main bar room windows is shown. More smoke is coming from the center window than the two side windows because the upper and lower portions of the center window have been removed while only the lower portion of the side windows are open in the simulation.

Figure 5-50. View of smoke plumes from front windows of horseshoe bar area (176 seconds)

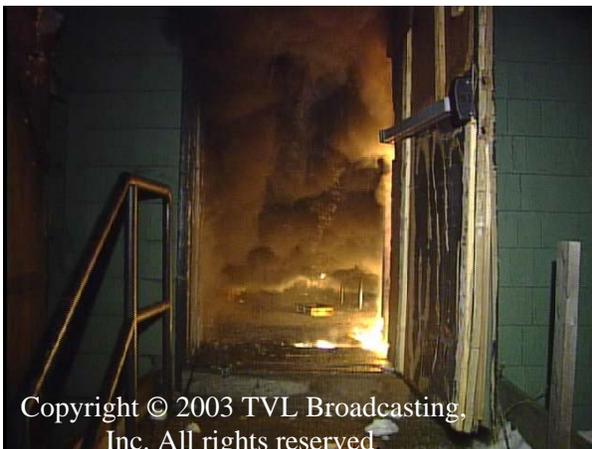
The videographer moves around to the stage door again. The view inside the open door at approximately 289 seconds after ignition is shown in Figure 5-51. The image from the simulation agrees with the video image on the level of combustion products in the doorway. However without a comparison to the temperature in the doorway, the mixture fraction alone would indicate that more flames are in the area of the stage doorway than can be seen in the video image. The videographer continues around to the backside of the nightclub, at 300 seconds after ignition flames are coming through a small portion of the back wall (south wall) of the dance floor area and smoke is leaking from the bathroom hallway wall. The videographer moved toward the front of the nightclub again, at 309 seconds flames can be seen in the area of the front door. It takes another 25 seconds before he is in a position to record the images of the flames coming from the sunroom windows and the main door. The simulation stops at 300 seconds after ignition, short of the time that the entire nightclub reaches flashover conditions.

Figure 5-51. Looking into stage door exit (289 seconds)

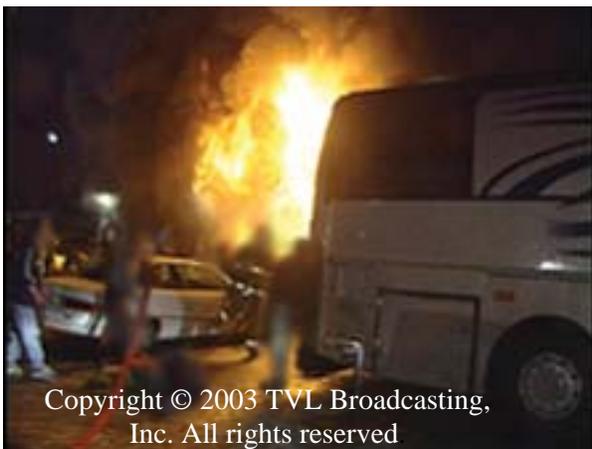
Figure 5-52. Flames breaking through front door and sunroom windows (337 seconds video, 300 seconds simulation)

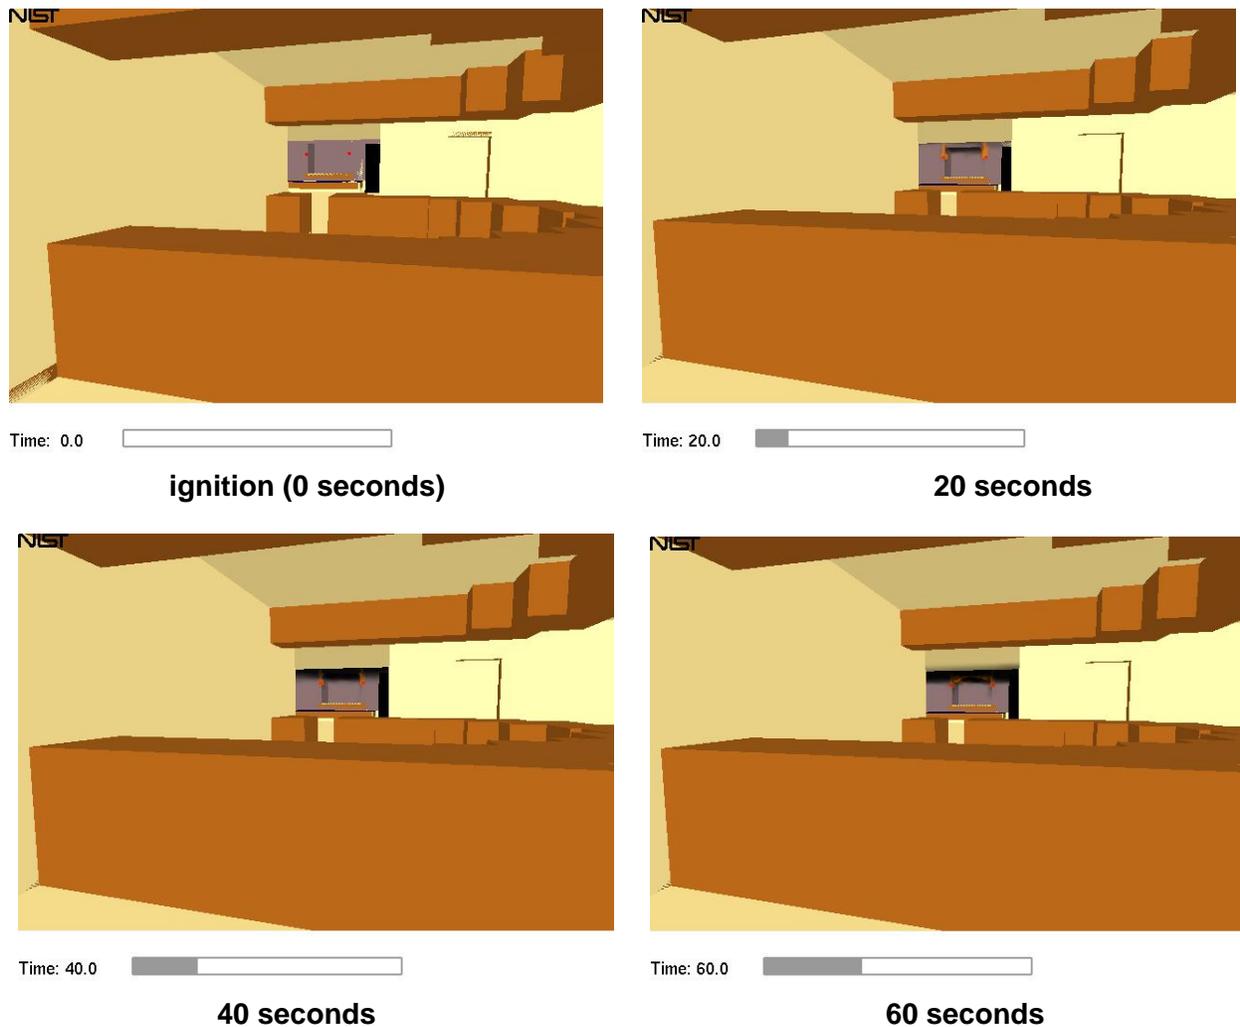
Smokeview images were rendered at certain time intervals from the view looking through the far side of the main bar to the platform area. (See Figures 5-53a,b.) This allowed for the conditions to be observed at several key locations: the platform area, the entrance to the main exit way and the main bar area. Many of the occupants traveled this path as either they were able to exit or were overcome by the conditions prior to being able to do so. The fire developed quickly in the platform area as the foam burned and resulted in the alcove becoming fully developed with fire. Once that occurred the flames involved the entire rear wall and spread toward the main entrance, generating large amounts of smoke. At 70 seconds after ignition, the smoke can be seen in the area of the main entrance to the nightclub. This is consistent with the WPRI video. As the videographer leaves the nightclub, at approximately 70 seconds after ignition, smoke is flowing over the heads of people in the main entry foyer. However, even 80 seconds after ignition visibility remained high in the main bar room. This changed suddenly as the smoke and hot gases that were spilling out of the now-filled raised ceiling above the dance floor quickly spread to the main bar room. Based on the FDS simulation, within another 20 seconds, 100 seconds after ignition visibility was impaired, and remained so throughout the rest of the 300 seconds simulation. Flames can be seen in the last three images of Figure 5-53b as the surfaces in the main bar area began to burn.

Figure 5-53a. View of fire from beyond horseshoe bar, looking at platform (0 - 60 seconds)

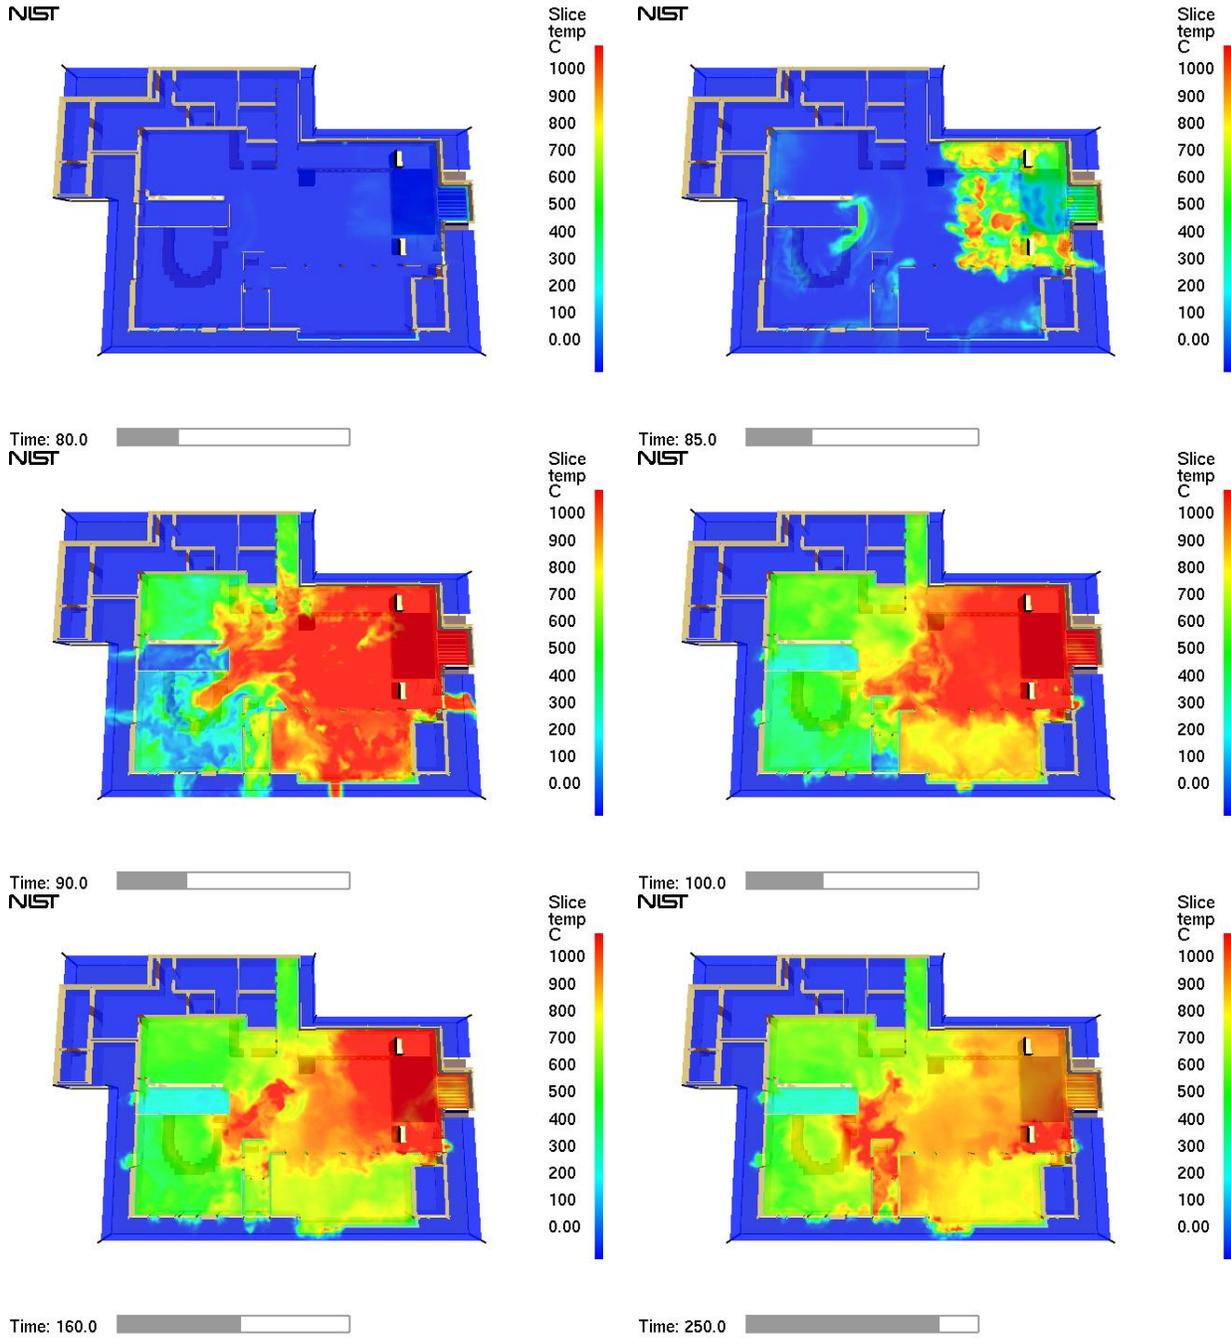
Temperatures increase dramatically shortly after the alcove area reaches flashover conditions at approximately 65 seconds and then the platform area becomes fully involved in flames. The first two images in Figure 5-55 show the temperatures at 1.5 m (5 ft) above the floor at 80 and 85 seconds. Within that 5 second time interval the simulation predicts that dance floor area of the nightclub would have become untenable due to temperature. By 100 seconds after ignition, the simulation shows a large portion of the structure had become untenable due to temperature at the 1.5 m (5 ft) level. Figure 5-55 continues with the presentation of simulation temperature results from 160 seconds to 250 seconds after ignition. During this time interval temperatures continue to remain in the untenable range throughout the simulated nightclub, with the exception of areas that are considered closed off from the hot gas flow such as the

bathrooms, office and storage areas. These areas were assumed to be separated from the rest of the nightclub by closed doors, so they were modeled without a path for the gases to enter the spaces, hence they appear to remain in the tenable range. The kitchen area has an open door from the dart room and an open door that exits to the outside. The hot gas flow goes directly from the dart room to the exit doorway. This leaves the kitchen at a cooler temperature than the surrounding rooms.

Figure 5-55. Temperatures at 1.5 m (5 ft) above the floor, 80 seconds to 250 seconds

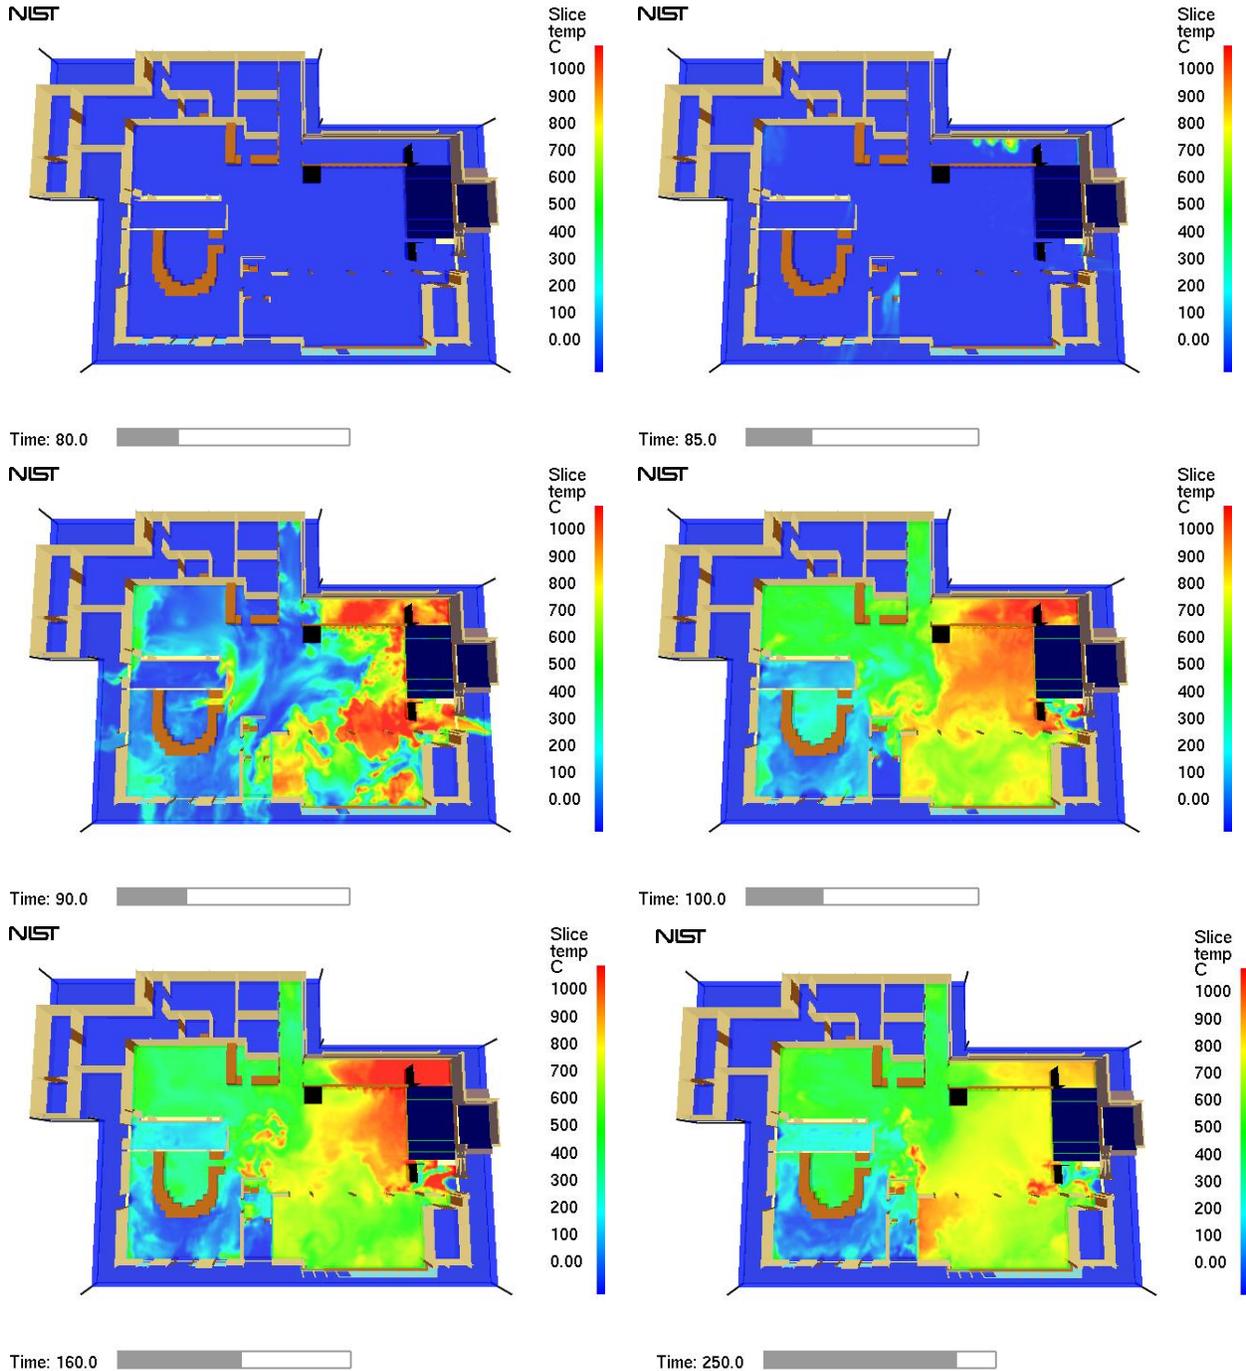
At the 0.6 m (2 ft) height above the floor conditions remain tenable for a longer period of time than at the higher elevation. Figure 5-56 contains images captured at the same time intervals as in the previous figure. One can see that the dance floor and adjacent areas reach untenable temperatures in the simulation within 90 seconds after ignition. The sunroom and dart room areas are predicted to reach untenable temperatures within another 10 seconds.

Figure 5-56. Temperatures at 0.6 m (2 ft) above the floor, 80 seconds to 250 seconds

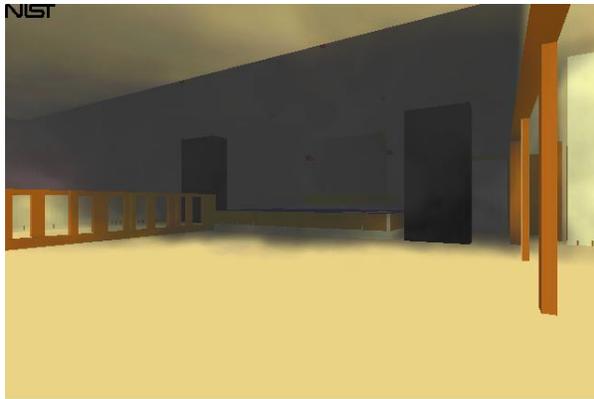
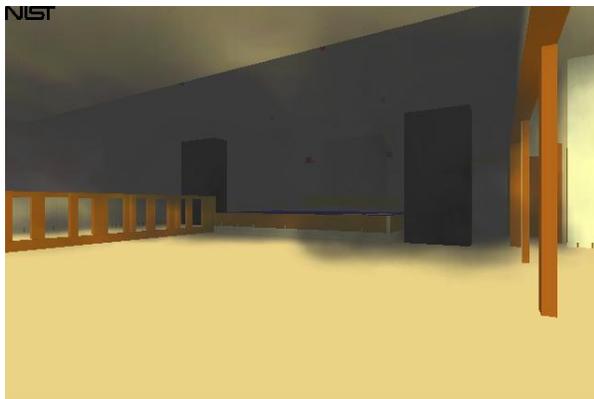
Figures 5-63a and 5-63b are rendered from Smokeview to examine the flame and smoke spread and the effect of the sprinklers. The images begin at ignition or $t = 0$ seconds and continue until 100 seconds after ignition. The first image in Figure 5-63a shows the two sprinklers over the platform area and the two sprinklers over the dance floor as small red dots along the ceiling. The larger red areas on the platform walls represent the location of the ignition burners. The sprinkler located on the ceiling of the alcove is hidden from view. The second image rendered at 20 seconds shows smoke being pushed away at the first sprinkler, which activated at 16 seconds after ignition. By 30 seconds after ignition, three of the sprinklers had been activated. This caused some of the smoke to be pushed down to the floor. The two sprinklers over the dance floor area did not activate during the simulation. Figure 5-63b has images from 70 seconds to 150 seconds after ignition. During this period the fire was significantly suppressed. The series of images show the smoke dispersing. The fire was extinguished fully at approximately 114 seconds. The smoke continued to spread and is diluted by fresh air entering the area.

Figure 5-63b. Simulation of nightclub with sprinklers, 70 seconds to 150 seconds

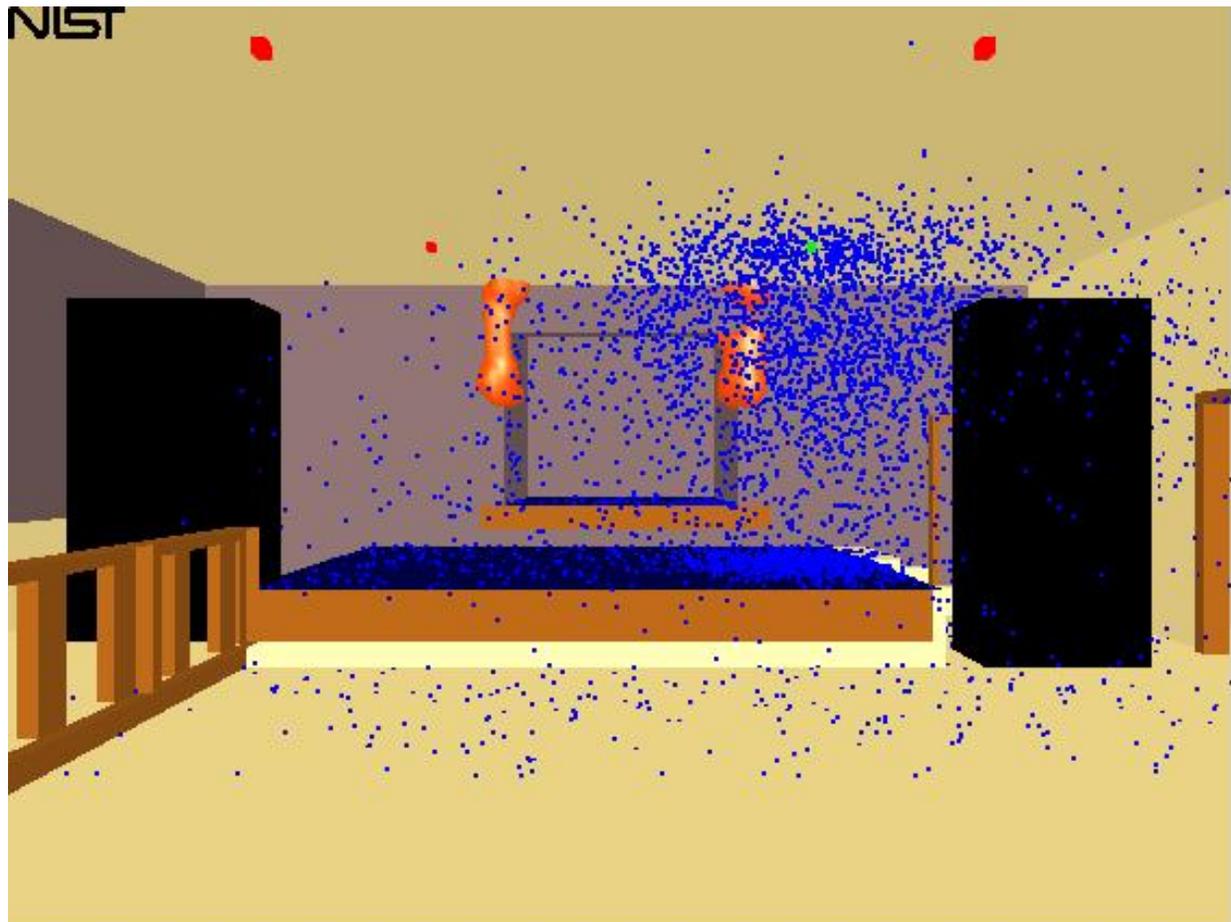
Figure 5-64. Simulation of northwest sprinkler activation 18 seconds after ignition, showing water flow with smoke "turned off."

Figure 5-64 provides another means of looking at the simulation. This image, rendered at 2 seconds after the first sprinkler activated, includes the visualization of the sprinkler droplets but does not include the visualization of the smoke. Notice that the activated sprinkler has changed color from red to green.

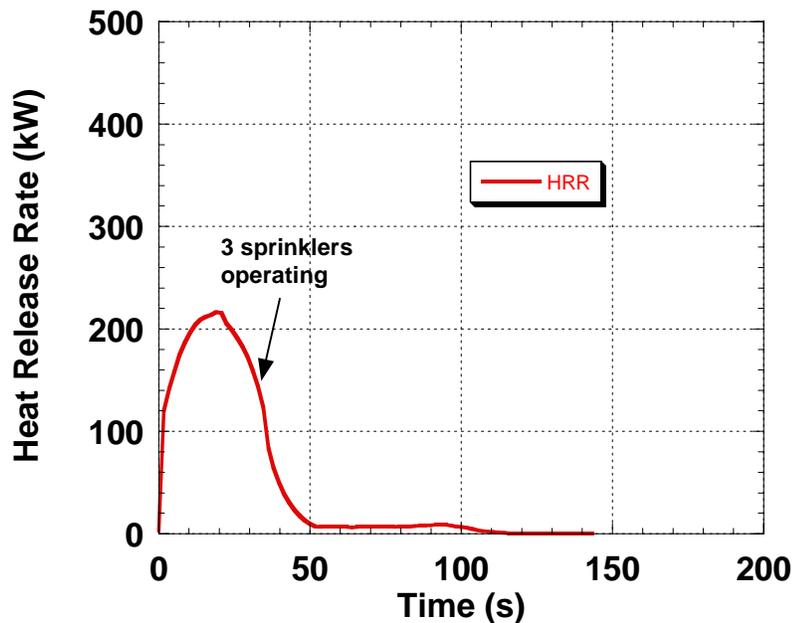
Figure 5-65. FDS predicted heat release rate for the sprinklered case.

Figure 5-65 shows the FDS predicted heat release rate for the sprinklered simulation. The heat release rate reached its maximum of approximately 220 kW at 20 seconds. This heat release rate quickly declined as the three sprinklers activated and suppressed the fire.

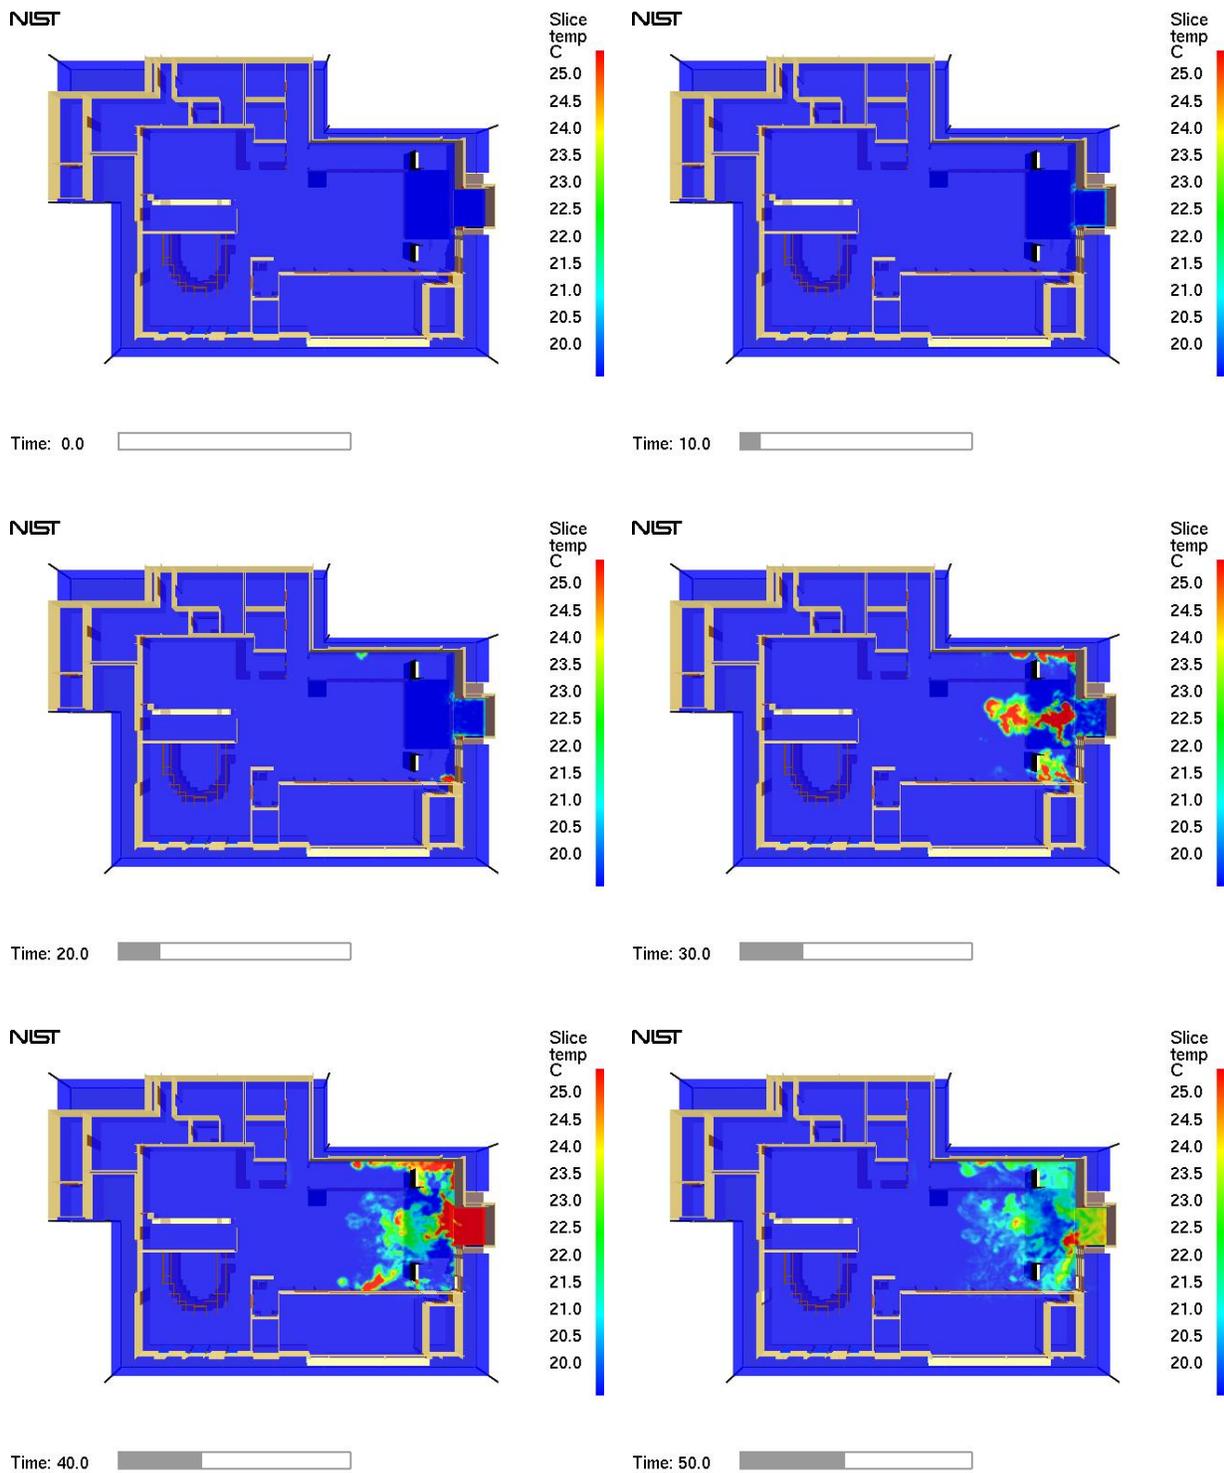
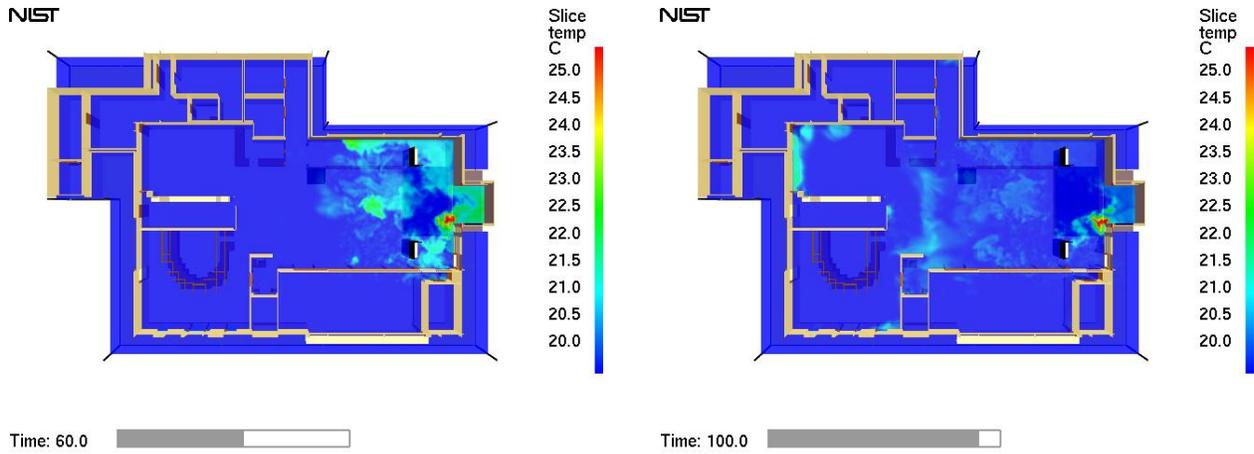
Figure 5-66a. Temperatures at 1.5 m (5 ft) above the floor, 0 seconds to 50 seconds

Isothermal plots are shown in Figures 5-66a and 5-66b to assess the tenability conditions based on temperatures that were predicted during the simulation of the fire. The figures show horizontal isothermal images 1.5 m (5 ft) above the floor from the time of ignition ($t = 0$) to 100 seconds at 10 second intervals, and an image at 150 seconds. Due to the rapid activation of the sprinklers (three sprinklers were operating by 30 seconds after ignition), the temperatures at the 1.5 m (5 ft) level remain well below the temperature tenability threshold of 120 °C (248 °F) [6].

The comparison between the temperatures 1.5 m (5 ft) above the floor in the non-sprinklered simulation (Figure 5-55) and in the sprinklered configuration (Figs. 5-66a and 5-66b) show dramatically different thermal conditions. (Note the large difference in color scales.) During the non-sprinklered simulation temperatures exceeded 1000 °C (1830 °F) in the platform and dance floor areas, and in the main bar room they exceeded 500 °C (930 °F) within 100 seconds. In the sprinklered simulation, the temperature exceeds 25 °C at head height only near the platform; following sprinkler activation around 20 seconds, the thermal environment remains close to ambient up until the time the fire is fully extinguished at 120 seconds.

Given the limited fire spread and the resulting tenable gas temperatures, the heat flux tenability criteria was never exceeded in the sprinklered case.

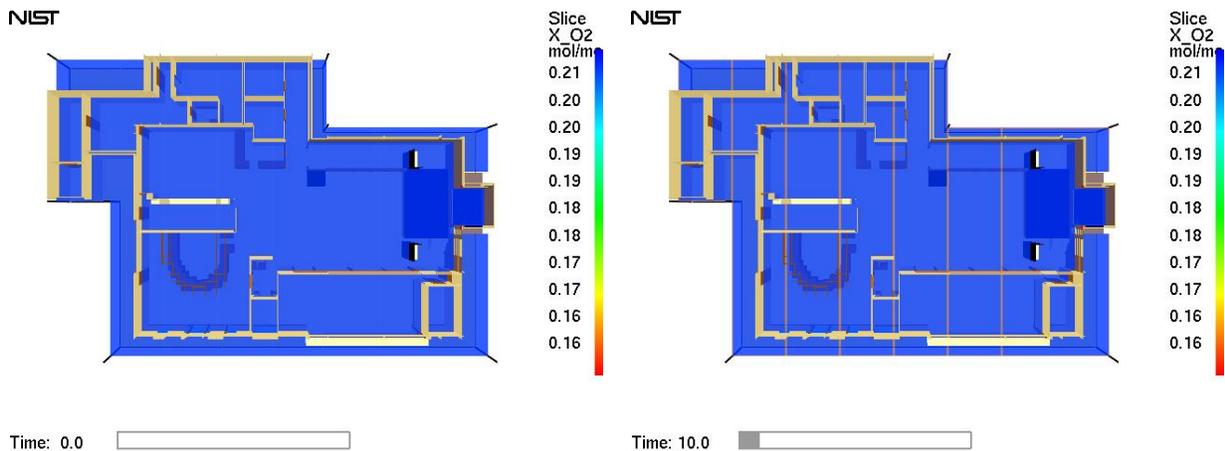
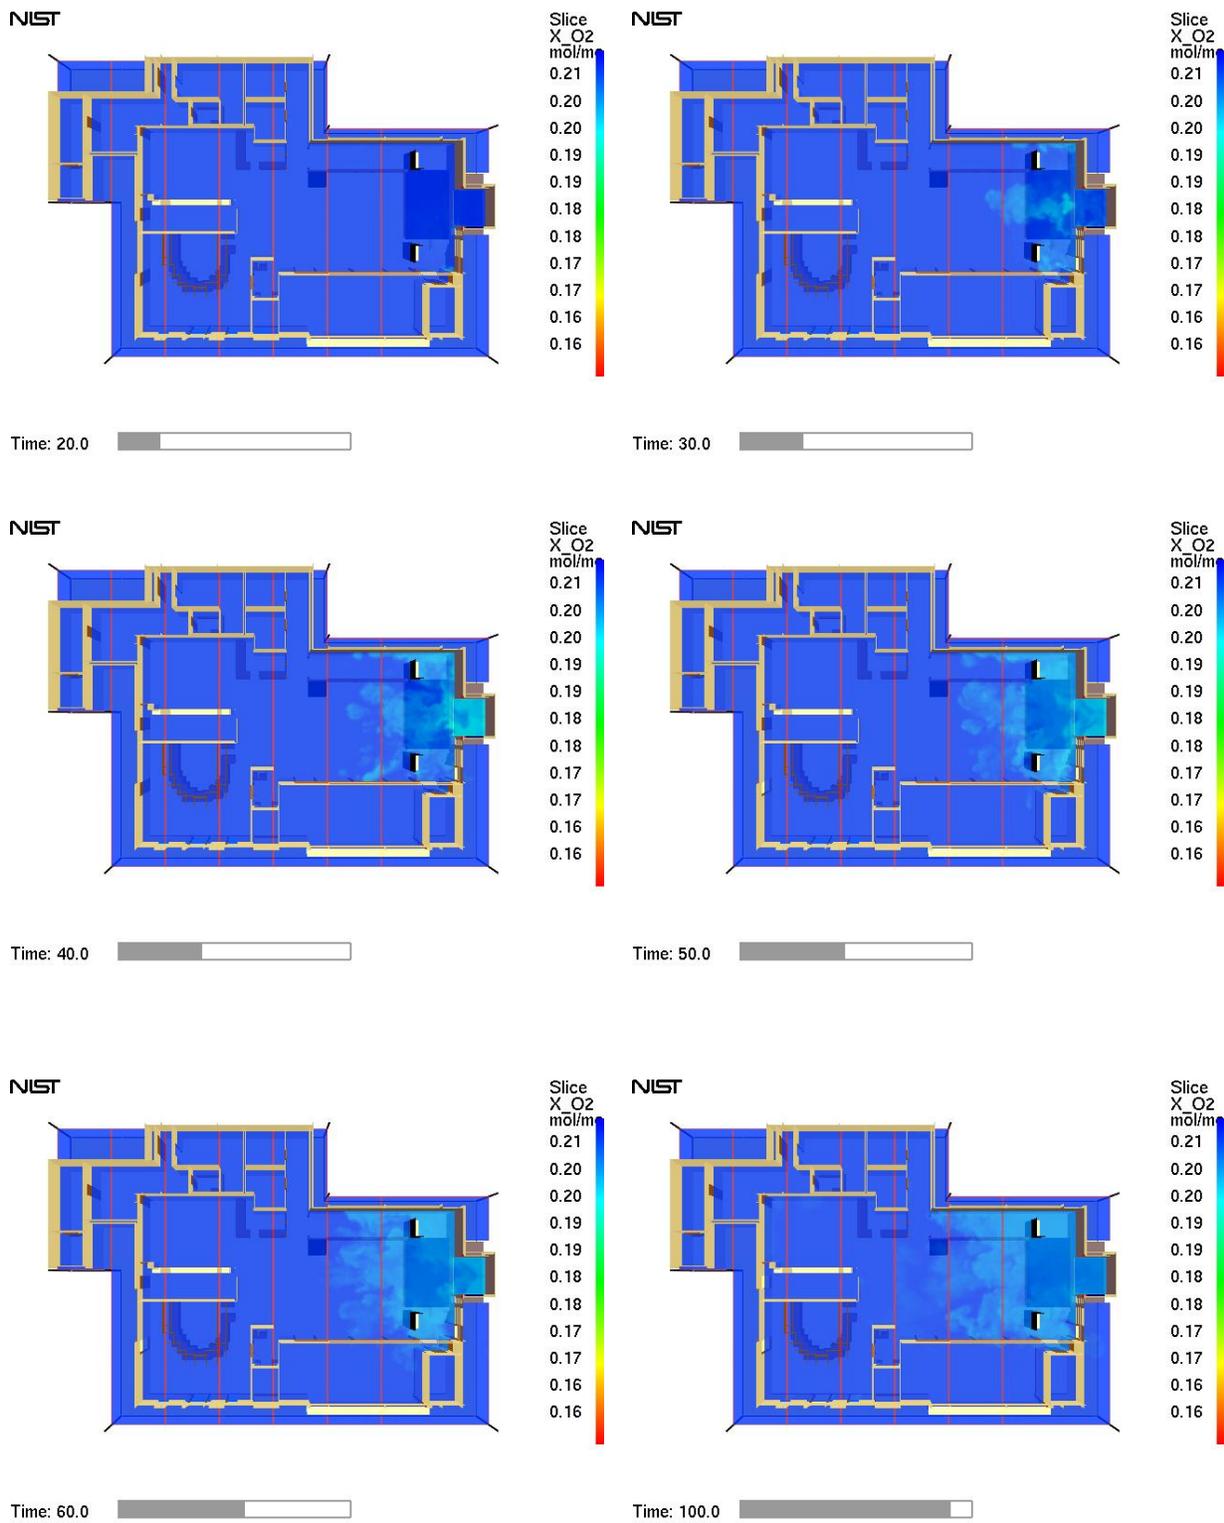
Figure 5.67a. Oxygen volume fractions at 1.5 m (5 ft) above the floor, 0 seconds and 10 seconds

Oxygen volume fractions were also examined in the sprinklered simulation to assess the tenability conditions that existed during the evolution of the fire. Horizontal slices were taken at the 1.5 m (5 ft) level with the roof removed to examine the structure as a whole. The analysis utilized a volume fraction of 0.12 as the oxygen tenability threshold [6]. Based on that oxygen limit, Figures 5-67a and 5-67b demonstrate that the atmosphere remained tenable during the entire duration of the simulation. In contrast, the non-sprinklered simulation predicted oxygen levels below 0.12 at the 1.5 m (5 ft) elevation throughout the building at 100 seconds after ignition and then continuing at untenable concentrations during the remainder of the simulation.

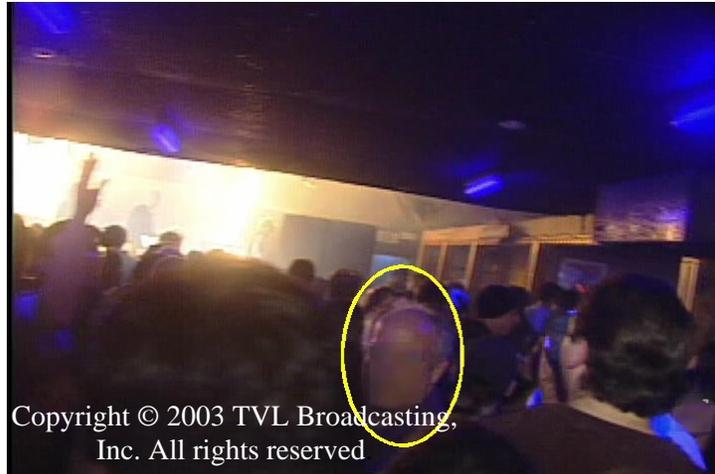
Figure 6-1. Occupant at Start of Evacuation [2]

Efforts were made to track individuals from their location in the club when the fire ignited until they had evacuated. One male occupant, shown facing the camera in Figure 6-1, was tracked through evacuation. The time of this still frame is 0:06:51 video time (0:00:29 fire time). The occupant's face has been blurred in the figures below in order to preserve his anonymity; his facial features were not critical for the identification analysis.

After the ignition of the fire, the camera operator began reacting before most other occupants did. The camera captured the occupant shown in Figure 6-1 29 seconds after the ignition of the fire turning and beginning to move toward the door. At this point, the camera was approximately two rows of people behind this man (between him and the main exit). This occupant can be seen reaching and crossing the main exit at 0:07:31 video time (0:01:09 fire time), 39 seconds later, in Figure 6-2.
