NIST NCSTAR 2: Vol. I

Report of the Technical Investigation of The Station Nightclub Fire

June 2005

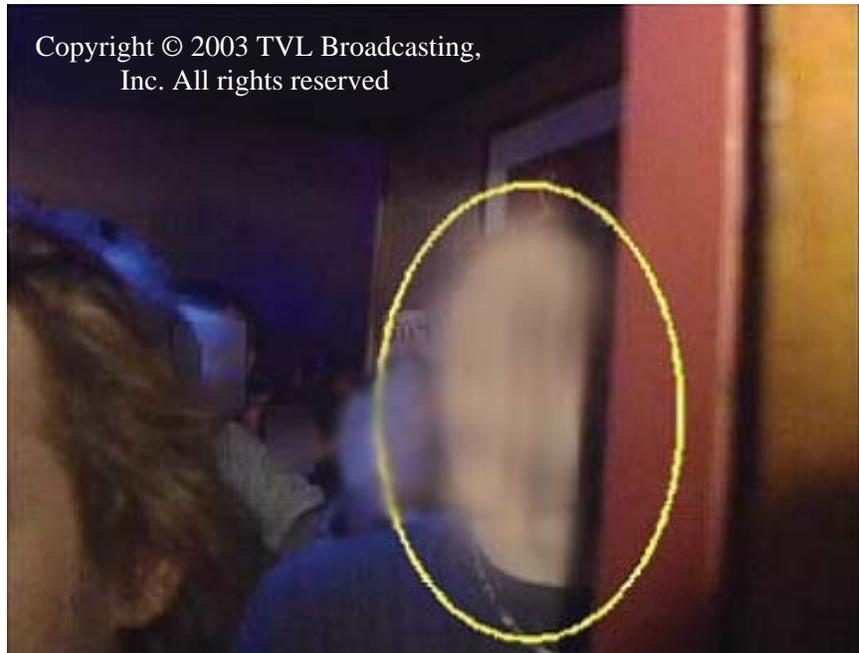
Figure 6-4 Occupant Attempting to Evacuate [2]

Forty-one seconds elapsed between Figure 6-4 (0:01:02 fire time) and when the occupant was first seen near the bottom of the pile. Because the camera operator moved to the side of the building immediately upon exiting through the main exit, it is not known when the individual shown in these figures reached the door and fell to that position.

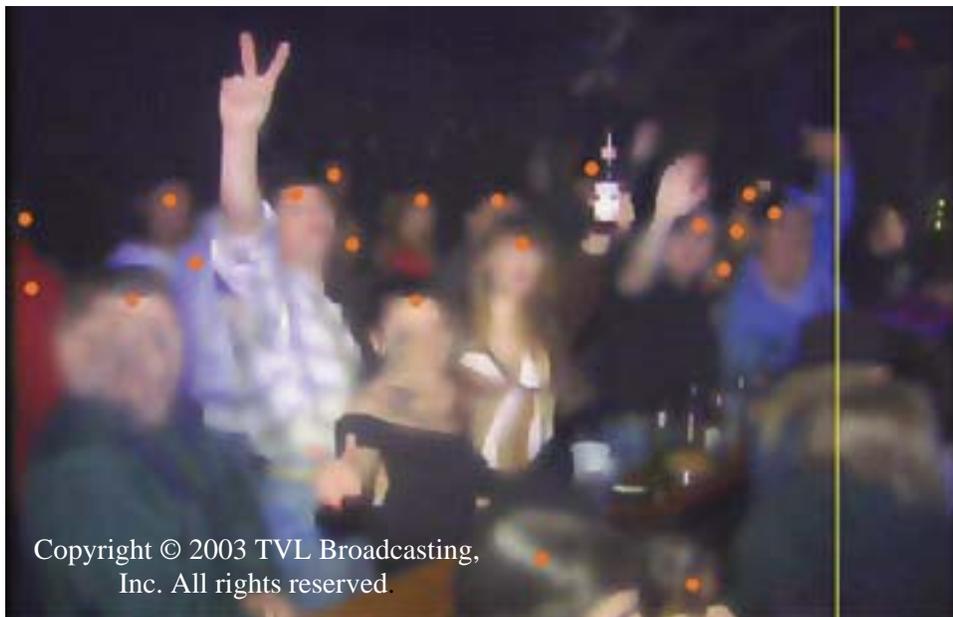
sequence in Figures 6-5 through 6-8 as the camera pans from right to left. The occupants shown in these still frames were counted in an effort to derive an approximate occupant load for the area shown. Orange dots have been used to represent counted occupants. The yellow lines in these Figures represent the boundaries where the frames overlap. A total of 144 occupants can be seen in these four figures. It is not clear at what time in relation to the start of the concert this video sequence was recorded. If it was recorded well before the main musical act, then it is likely that many occupants were located outside of the main platform viewing area at this time (i.e., many occupants may have been near one of the bars, in the pool room, or in the restrooms). Conversely, if this sequence was recorded immediately prior to the start of the primary musical act, then it is likely that the majority of the club's occupants would have moved towards the platform and into the performance assembly area. For these reasons it is not possible to extrapolate to a total building occupant load from this analysis. However, these figures can be helpful in estimating possible ranges of the number of occupants that may have been within the main platform viewing area.

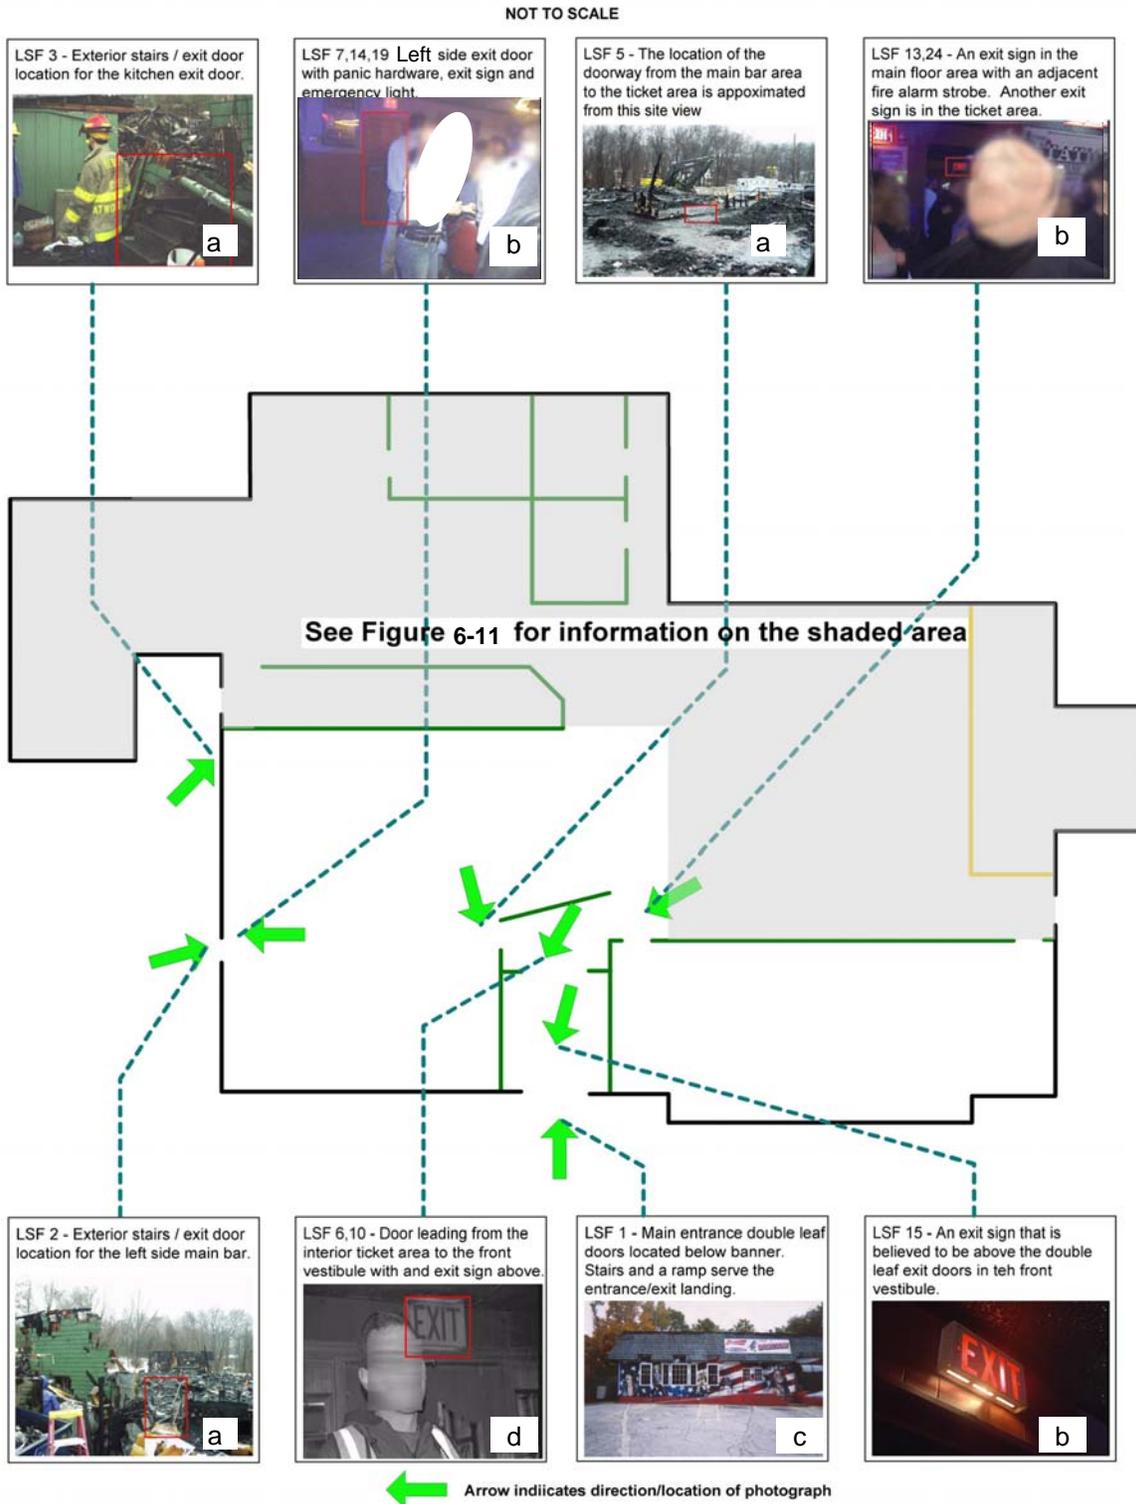
Figure 6-10. Summary of Life Safety Features – Part 1

Egress through the main entrance to the building was limited by a single interior door (LSF 6 in Figure 6-10) not the double doors that could be seen from outside the building.

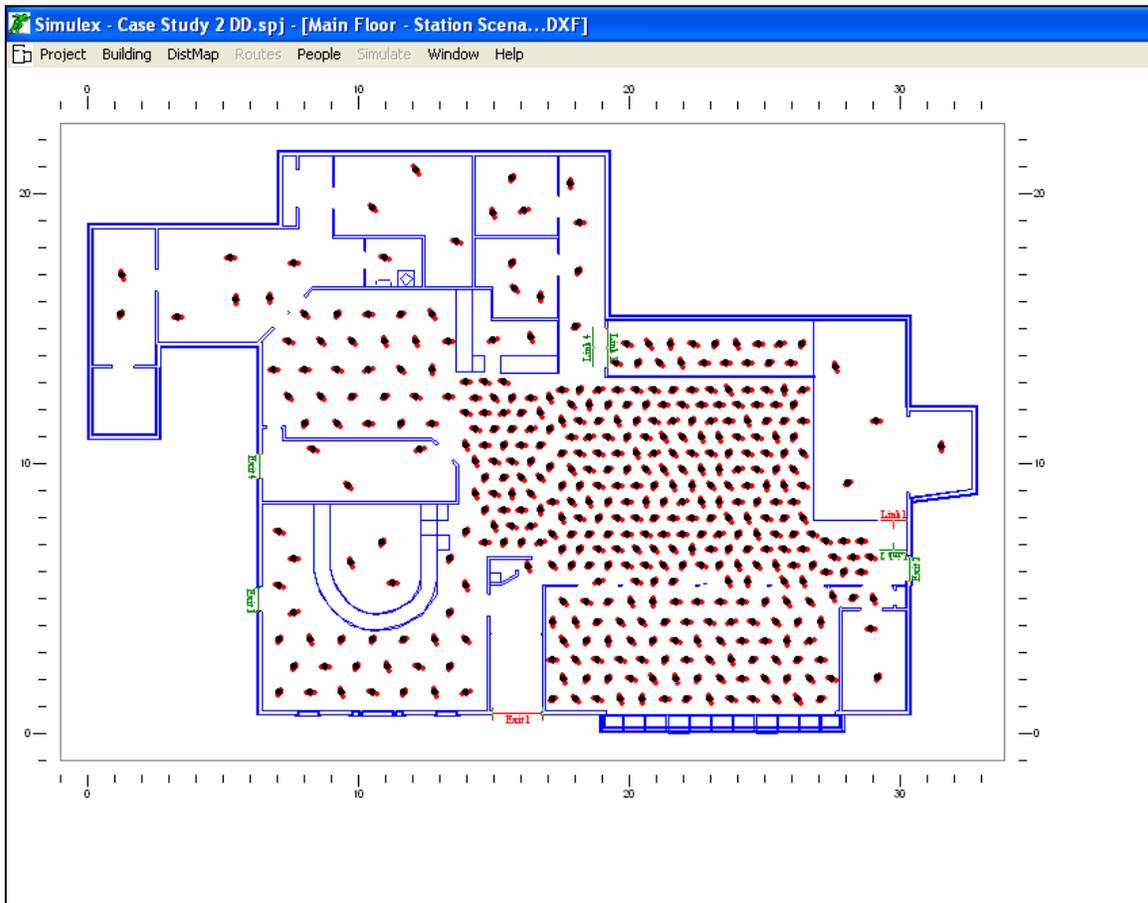
Figure 6-15. Initial distribution of 420 simulated nightclub patrons and employees

Scenario 3 investigated the impact of *doubling the width of the most restrictive element at the front entrance*. Figure 6-15 is one frame grabbed from the Simulex computer simulation indicating the initial population and distribution of patrons and employees. (This was typical of the initial conditions for all of the simulations.) The purpose was to see how this affected the evacuation time in the event that one of the other exits became blocked (e.g., due to construction, negligence or a criminal act). Simulex and

buildingEXODUS calculated a total egress exit time of 196 seconds \pm 2 seconds, almost identical to the baseline case in scenario 1. The main difference in the outcome for scenario 3 was the larger number of occupants using the front entrance to escape, about 87 % of the total. Assuming that doubling the width of the restrictive front entrance would also have reduced the possibility for a crowd crush to develop, this change would bring the level of safety equivalent to what was implied by the current model codes.

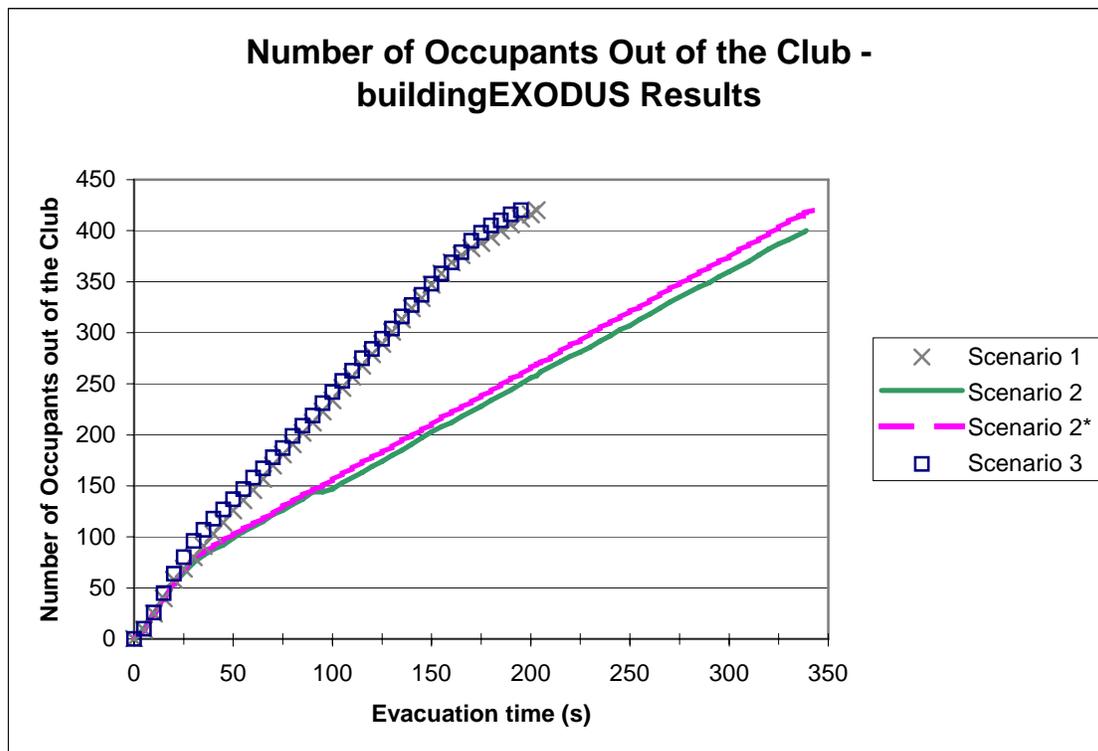
Figure 6-16. Cumulative plot of evacuation from building for different scenarios calculated from buildingEXODUS [39]. (Note that a non-zero pre-movement time would shift the curves to right.)

Figures 6-16 and 6-17 compare the cumulative population that was evacuated as a function of time for the scenarios described above, based upon the results of buildingEXODUS [39] and Simulex [37, 38] respectively. If one draws a vertical line up from the time scale at 90 seconds, the total number of people who remained in the nightclub at that time can be determined.

Ninety seconds had significance on Feb. 20 because that was about the time the front entrance became blocked and, according to the fire dynamics simulations, was a point where the conditions were becoming untenable throughout the building. The last column in Table 6-2 lists the population remaining for both the buildingEXODUS and Simulex simulations. Note that buildingEXODUS, when compared to Simulex, consistently provided a more conservative (i.e., a slower) rate of egress, which is consistent with the conservative flow rates chosen for the exit doors in buildingEXODUS.

Somewhere between 166 and 208 people were calculated to remain in the building 90 seconds after the fire began for the scenario in which the building met current national model code requirements. This number jumped to 271 for scenario 2, with the platform door blocked (recall that the front door remained open during the first 90 seconds). Doubling the entrance door width in scenario 3 brought the number of people remaining in the building 90 seconds into the fire back down to the range calculated for scenario 1. Finally, since the crowd-crush had not occurred prior to 90 seconds, the calculation for the 2* scenario is essentially the same as for scenario 2.

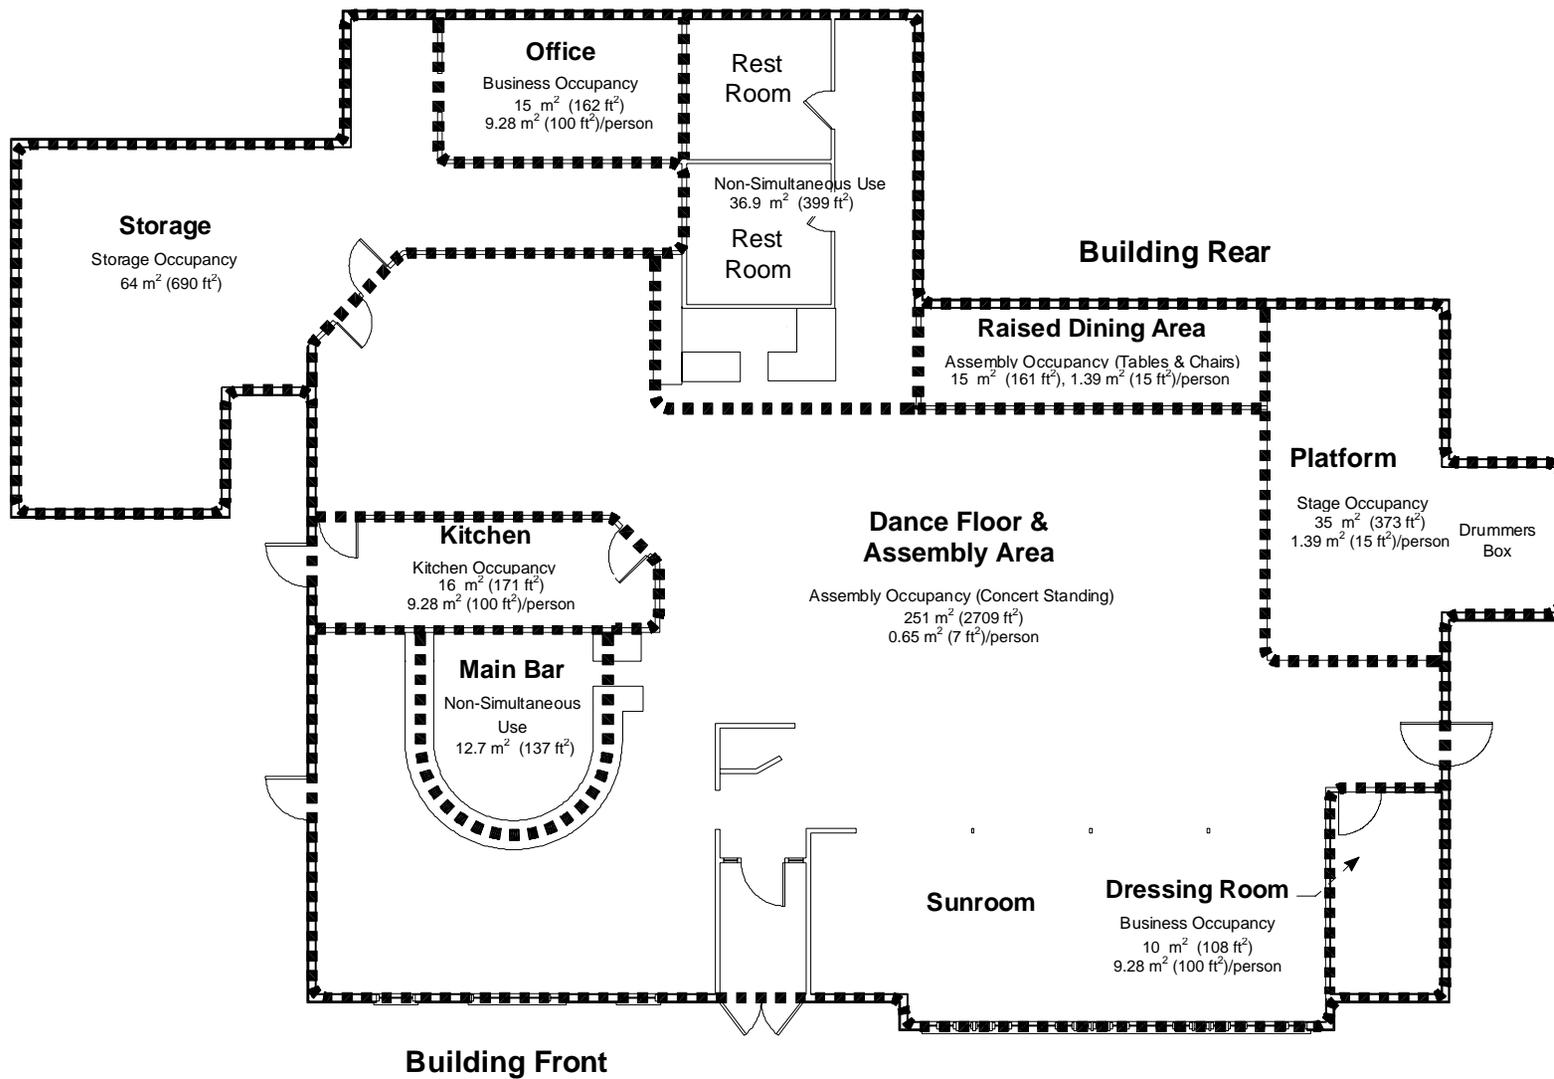
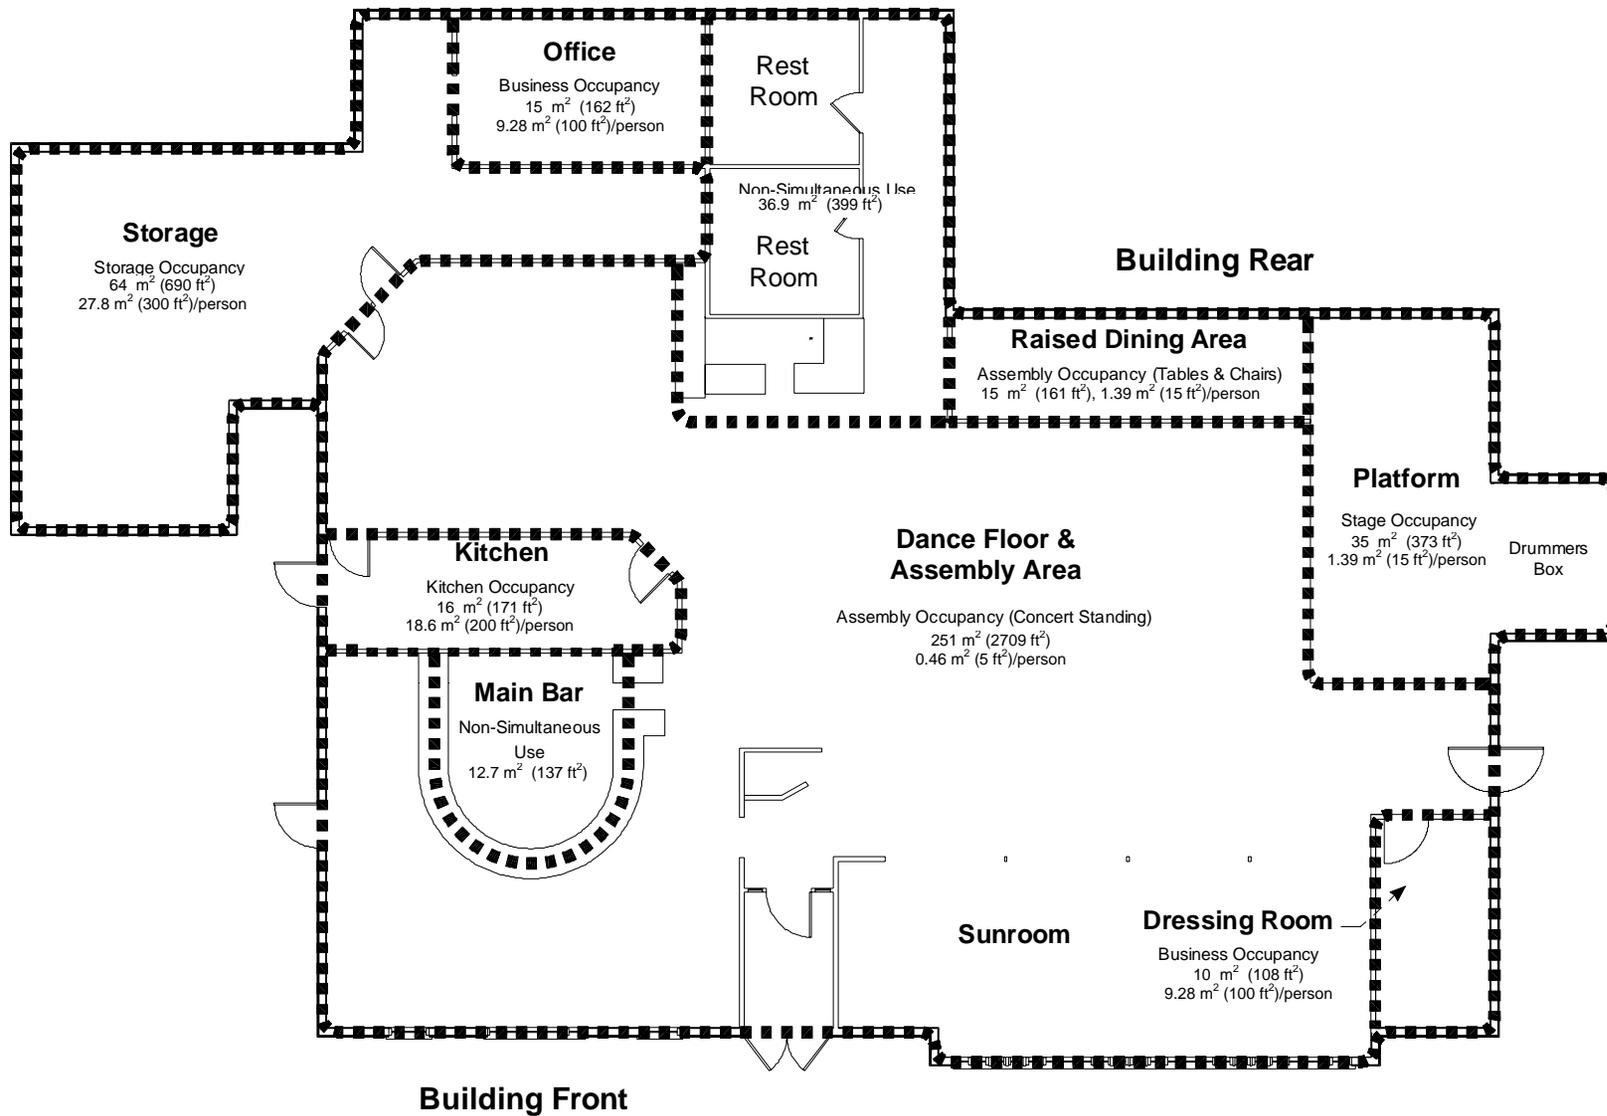
Comment: Refer to Figure 7-3 and Figure 7-4 for the use of spaces within the Station as defined by the model codes. Based upon those uses, the maximum load for each space is computed in Table 7-4. The total maximum occupancy of a building similar to The Station, according to IBC,

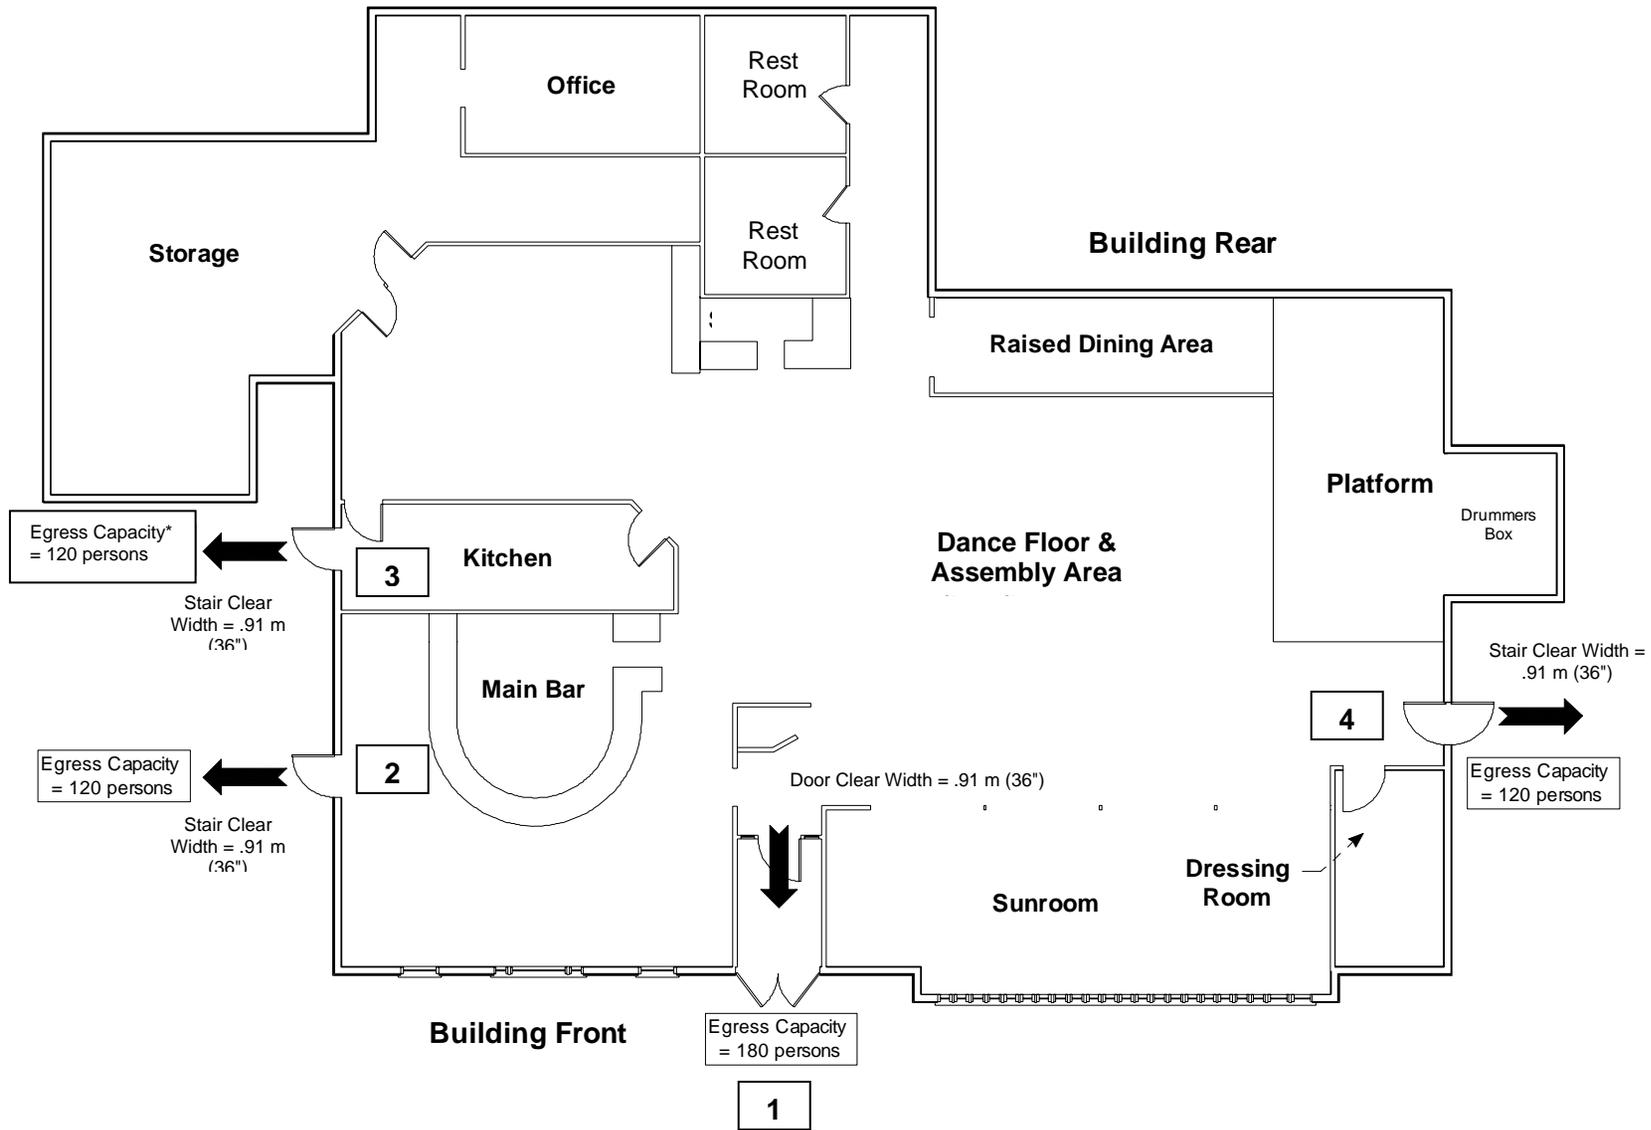
Figure 7-5. Station Nightclub Egress Capacity (*Note that model codes exclude exiting through a kitchen when calculating occupancy limit.)

There were four exit routes from the building, as numbered in Figure 7-5: (1) the front main exit, (2) the main bar exit on the side, (3) the kitchen exit, and (4) the platform exit. The model codes govern their number, size, placement, and other details of design, as discussed in this section

Comments: All doors exceeded the 0.81 m (32 in) minimum, and all door leaves swung in the direction of egress travel with the exception of the interior leaf at exit 4. (See Fig. 7-5.)

Comments: When viewed from the exterior, the right leaf of the front doors was not equipped with panic hardware. There was no visible hardware on either door. As of this writing, the type of hardware on the swinging door immediately inside the double exterior doors is undetermined. (See Fig. 7-5.)
